Contract #: 04-0120F4Cty: SF/ALA Rte: 80 PM: 13.2/13.9File #: 1x.28**WELDING INSPECTION REPORT****Resident Engineer:** Siegenthaler, Peter**Address:** 333 Burma Road**City:** Oakland, CA 94607**Report No:** WIR-025359**Date Inspected:** 26-Jul-2011**Project Name:** SAS Superstructure**OSM Arrival Time:** 700**Prime Contractor:** American Bridge/Fluor Enterprises, a JV**OSM Departure Time:** 1530**Contractor:** American Bridge/Fluor Enterprises, a JV**Location:** Job Site**CWI Name:** William Sherwood**CWI Present:** Yes No**Inspected CWI report:** Yes No N/A**Rod Oven in Use:** Yes No N/A**Electrode to specification:** Yes No N/A**Weld Procedures Followed:** Yes No N/A**Qualified Welders:** Yes No N/A**Verified Joint Fit-up:** Yes No N/A**Approved Drawings:** Yes No N/A**Approved WPS:** Yes No N/A**Delayed / Cancelled:** Yes No N/A**Bridge No:** 34-0006**Component:** OBG COmponents**Summary of Items Observed:**

WELDING INSPECTION REPORT

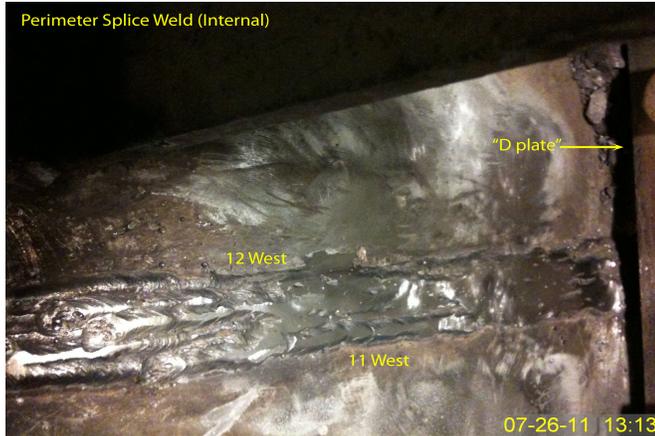
This QA randomly observed ABF/JV qualified welder Jorge Lopez perform Complete Joint Penetration (CJP) groove welding of cover pass on the splice butt joint where the track mounted "Bug-O" nozzle holder has limited access. The location was at OBG 11W/12W side plate (750mm) inside at intersection of the side and bottom plate (D/C). The welder was observed performing manual welding in the 3G (vertical) position utilizing a Shielded Metal Arc Welding (SMAW) with 1/8" diameter E7018H4R electrode and implementing Caltrans approved Welding Procedure Specification (WPS) ABF-WPS-D15-1040B. The joint being welded has a single V-groove butt joint with backing bar.

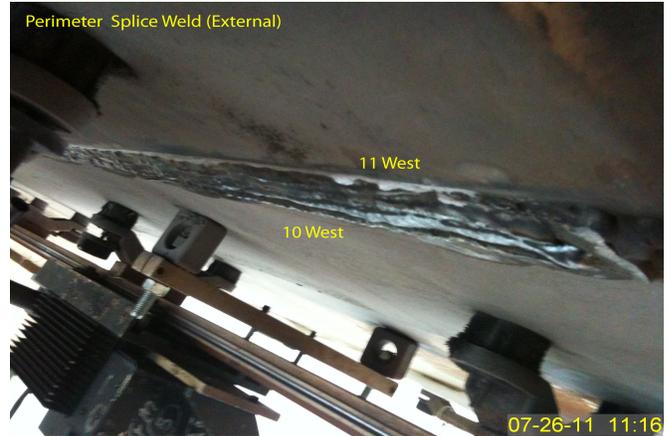
This QA Inspector randomly observed ABF welding operator Jin Pei Wang ID#7299 performing Flux Core Arc Welding w/gas (FCAW-G) operations in the 3G vertical position on side plate C on the outside of the OBG 10W/11W. The QA Inspector observed the QC Inspector William Sherwood as being present in order to monitor the progress and ensure the welding parameters were in compliance pertaining to ABF-WPS-D15-3042B-1. The QA Inspector noted that the work is appears to be in general conformance with the contract documents.
