DEPARTMENT OF TRANSPORTATION

Contract #: 04-0120F4Cty: SF/ALA Rte: 80 PM: 13.2/13.9File #: 1.28**WELDING INSPECTION REPORT****Resident Engineer:** Siegenthaler, Peter**Address:** 333 Burma Road**City:** Oakland, CA 94607**Report No:** WIR-025363**Date Inspected:** 26-Jul-2011**Project Name:** SAS Superstructure**OSM Arrival Time:** 700**Prime Contractor:** American Bridge/Fluor Enterprises, a JV**OSM Departure Time:** 1530**Contractor:** American Bridge/Fluor Enterprises, a JV**Location:** Job Site**CWI Name:** Steve Mc Connell**CWI Present:** Yes No**Inspected CWI report:** Yes No N/A**Rod Oven in Use:** Yes No N/A**Electrode to specification:** Yes No N/A**Weld Procedures Followed:** Yes No N/A**Qualified Welders:** Yes No N/A**Verified Joint Fit-up:** Yes No N/A**Approved Drawings:** Yes No N/A**Approved WPS:** Yes No N/A**Delayed / Cancelled:** Yes No N/A**Bridge No:** 34-0006**Component:** SAS Tower**Summary of Items Observed:**

At Tower Base Elevation 13Meters Shear Plate Electro Slag Welding (ESW);

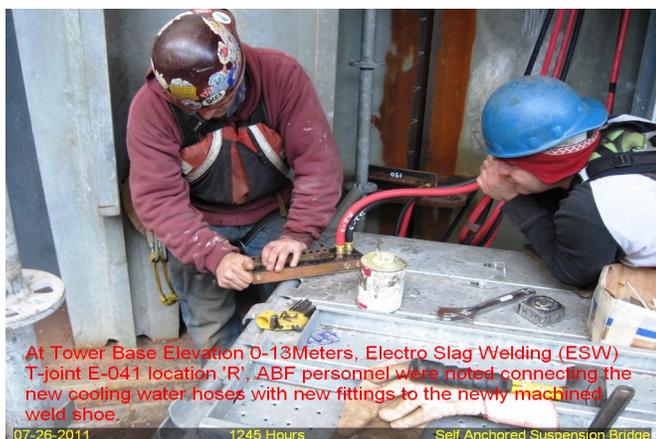
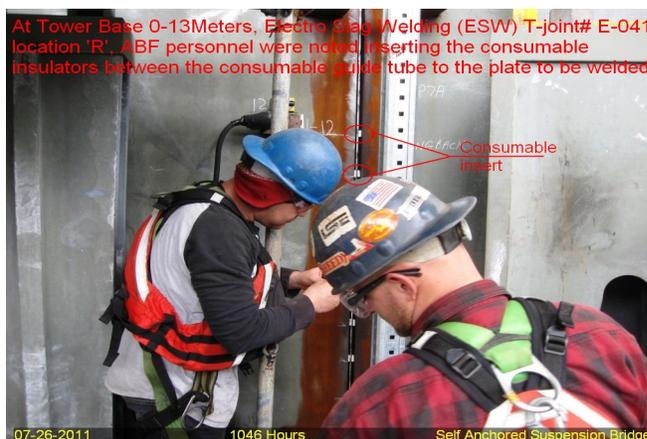
Initial firing of the ESW has started at 1435 hours but this was considered false start due to one filler wire was not moving and got stuck somewhere inside the consumable guide tube. ABF personnel momentarily stopped the operation and fixed the filler wire issue. After fixing and checking the filler wire, ABF has re-started the ESW at 1441 hours but again it was a false start due to same problem. ABF personnel tried again to fix the issue until 1500 hours when ABF Superintendent has decided to abort the operation and informed his personnel to perform the ESW tomorrow.
