DEPARTMENT OF TRANSPORTATION

Contract #: 04-0120F4Cty: SF/ALA Rte: 80 PM: 13.2/13.9File #: 1.28**WELDING INSPECTION REPORT****Resident Engineer:** Siegenthaler, Peter**Address:** 333 Burma Road**City:** Oakland, CA 94607**Report No:** WIR-025366**Date Inspected:** 27-Jul-2011**Project Name:** SAS Superstructure**OSM Arrival Time:** 700**Prime Contractor:** American Bridge/Fluor Enterprises, a JV**OSM Departure Time:** 1530**Contractor:** American Bridge/Fluor Enterprises, a JV**Location:** Jobsite**CWI Name:** William Sherwood**CWI Present:** Yes No**Inspected CWI report:** Yes No N/A**Rod Oven in Use:** Yes No N/A**Electrode to specification:** Yes No N/A**Weld Procedures Followed:** Yes No N/A**Qualified Welders:** Yes No N/A**Verified Joint Fit-up:** Yes No N/A**Approved Drawings:** Yes No N/A**Approved WPS:** Yes No N/A**Delayed / Cancelled:** Yes No N/A**Bridge No:** 34-0006**Component:** SAS OBG**Summary of Items Observed:**

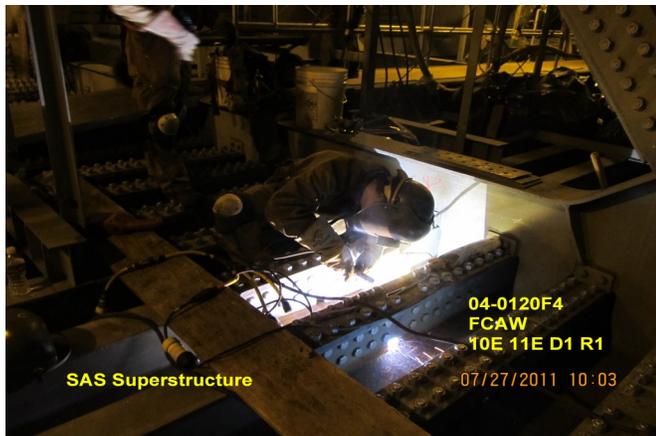
The QA inspector noted the dimensions of the excavation at D1 y=1270 as 150mm's in length and 18mm's deep. The QA inspector observed the QC Inspector identified as John Pagliero perform Magnetic Particle inspection on the site and found them to be acceptable. The QA inspector observed ABF welder Wai KitLai ID#2953 perform Shielded Metal Arc Welding (SMAW) in the 4G overhead position with the QC inspector being present in order to monitor the progress and ensure the welding parameters were in compliance pertaining to ABF-WPS-D15-1001-Repair. The QA inspector noted that the work is in progress and appeared to be in general conformance with the contract documents.

The QA inspector noted the dimensions of the excavation at D1 y=1460 as 110mm's in length, and 6mm's deep. The QA inspector observed the QC Inspector identified as John Pagliero perform Magnetic Particle inspection on

the site and found them to be acceptable. The QA inspector observed ABF welder Wai KitLai ID#2953 perform SMAW in the 4G overhead position with the QC inspector being present in order to monitor the progress and ensure the welding parameters were in compliance pertaining to ABF-WPS-D15-1001-Repair. The QA inspector noted that the work is in progress and appeared to be in general conformance with the contract documents.
