**DEPARTMENT OF TRANSPORTATION**

Contract #: 04-0120F4Cty: SF/ALA Rte: 80 PM: 13.2/13.9File #: 1.28**WELDING INSPECTION REPORT****Resident Engineer:** Siegenthaler, Peter**Address:** 333 Burma Road**City:** Oakland, CA 94607**Report No:** WIR-025368**Date Inspected:** 28-Jul-2011**Project Name:** SAS Superstructure**OSM Arrival Time:** 700**Prime Contractor:** American Bridge/Fluor Enterprises, a JV**OSM Departure Time:** 1730**Contractor:** American Bridge/Fluor Enterprises, a JV**Location:** Job Site**CWI Name:** John Pagliero**CWI Present:** Yes No**Inspected CWI report:** Yes No N/A**Rod Oven in Use:** Yes No N/A**Electrode to specification:** Yes No N/A**Weld Procedures Followed:** Yes No N/A**Qualified Welders:** Yes No N/A**Verified Joint Fit-up:** Yes No N/A**Approved Drawings:** Yes No N/A**Approved WPS:** Yes No N/A**Delayed / Cancelled:** Yes No N/A**Bridge No:** 34-0006**Component:** SAS Tower**Summary of Items Observed:**

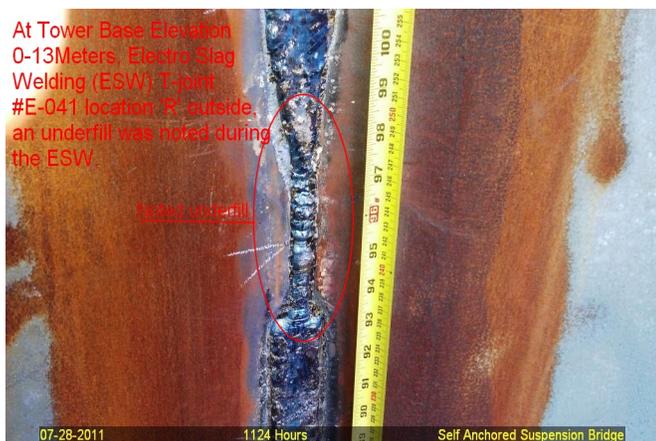
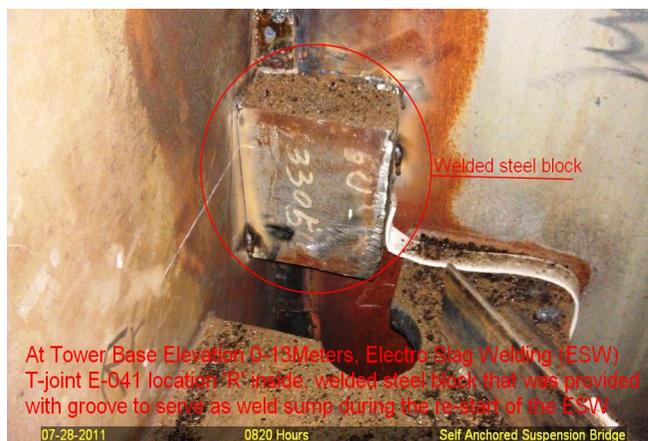
During the shift, this QA performed random inspection of the previously welded ESW weld joint E-041 location 'R'. It was noted that the weld cover from bottom 93" to 99" (6" long) was having an underfill. The steel block that was used during the re-start of the ESW due to power failure was noted still welded and not removed from the joint. The re-start weld joint was noted satisfactory from the outside but cannot verify from the inside due to the presence of the steel block.
