DEPARTMENT OF TRANSPORTATION

Contract #: 04-0120F4Cty: SF/ALA Rte: 80 PM: 13.2/13.9File #: 1.28**WELDING INSPECTION REPORT****Resident Engineer:** Siegenthaler, Peter**Address:** 333 Burma Road**City:** Oakland, CA 94607**Report No:** WIR-025370**Date Inspected:** 28-Jul-2011**Project Name:** SAS Superstructure**OSM Arrival Time:** 700**Prime Contractor:** American Bridge/Fluor Enterprises, a JV**OSM Departure Time:** 1530**Contractor:** American Bridge/Fluor Enterprises, a JV**Location:** Jobsite**CWI Name:** William Sherwood**CWI Present:** Yes No**Inspected CWI report:** Yes No N/A**Rod Oven in Use:** Yes No N/A**Electrode to specification:** Yes No N/A**Weld Procedures Followed:** Yes No N/A**Qualified Welders:** Yes No N/A**Verified Joint Fit-up:** Yes No N/A**Approved Drawings:** Yes No N/A**Approved WPS:** Yes No N/A**Delayed / Cancelled:** Yes No N/A**Bridge No:** 34-0006**Component:** SAS OBG**Summary of Items Observed:**

WELDING INSPECTION REPORT

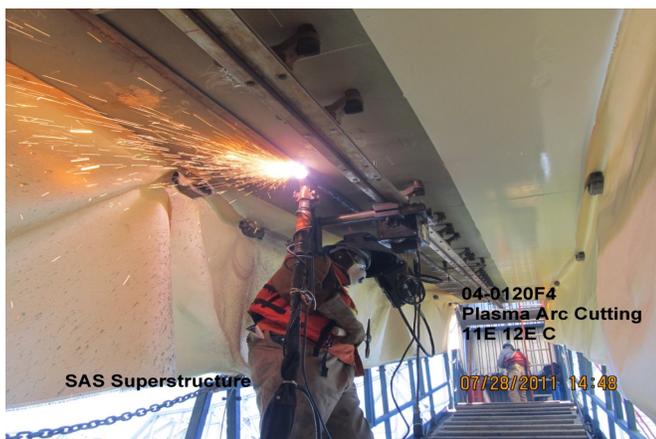
The QA inspector randomly observed ABF welder Fred Kaddu ID#2188 utilizing the Plasma Arc Cutting (PAC) method to remove the backing bar from the exterior face of side plate C at 11E 12E. The work progressed throughout the shift and the QA inspector noted that the work appeared to be in general conformance with the contract documents.
