DEPARTMENT OF TRANSPORTATION

Contract #: 04-0120F4Cty: SF/ALA Rte: 80 PM: 13.2/13.9File #: 1.28**WELDING INSPECTION REPORT****Resident Engineer:** Siegenthaler, Peter**Address:** 333 Burma Road**City:** Oakland, CA 94607**Report No:** WIR-025392**Date Inspected:** 03-Aug-2011**Project Name:** SAS Superstructure**OSM Arrival Time:** 700**Prime Contractor:** American Bridge/Fluor Enterprises, a JV**OSM Departure Time:** 1730**Contractor:** American Bridge/Fluor Enterprises, a JV**Location:** Job Site

Caltrans Office of Structural Material (OSM) Quality Assurance Inspector (QAI) Joselito Lizardo was present at the Self Anchored Suspension (SAS) job site as requested to perform observations on the welding of components for the San Francisco Oakland Bay Bridge (SFOBB) Project.

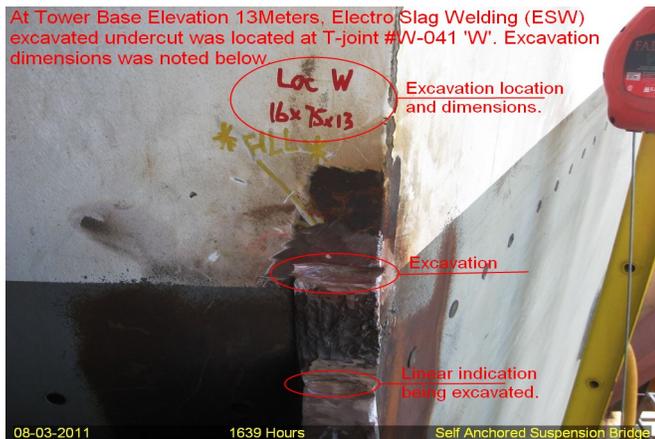
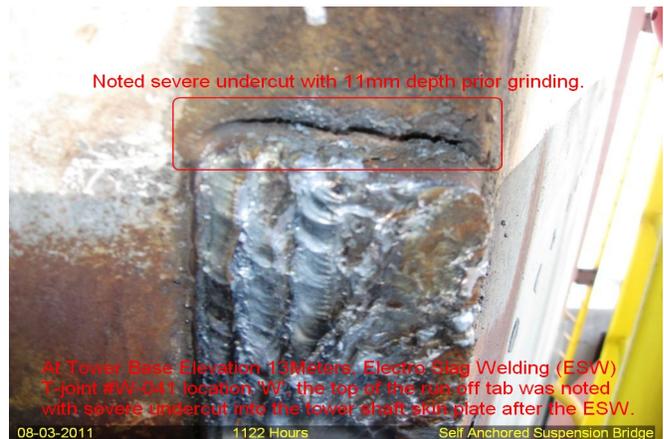
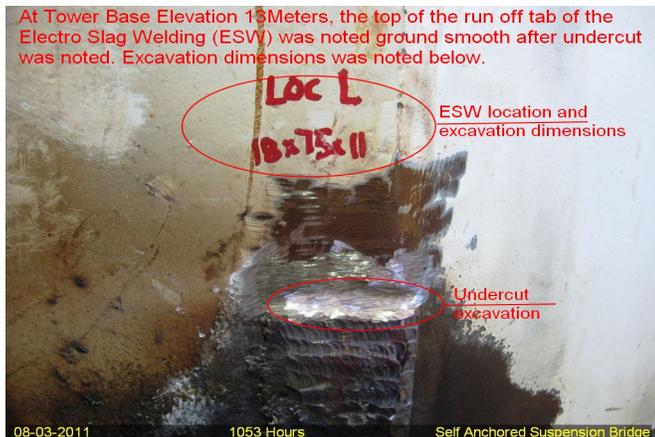
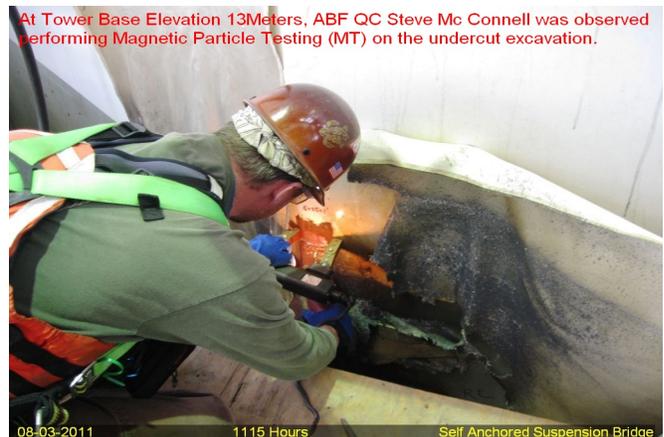
During the run off tab removal, ABF personnel have noted a slight to severe undercut that was caused by the Electro Slag Welding at the top of the weld. This could be due to the high temperature generated by the molten flux during the ESW and that the end welding was not covered by molten metal.

The following ESW weld locations were run off tab removed and noted with undercut right at the top where the ESW welding was terminated. The weld undercut were excavated and repaired as noted below.

1. 'R' (E-041) 75mm x 15mm x 10mm MT Passed Repair complete.
2. 'J' (N-042) 65mm x 20mm x 7mm MT Passed Repair complete.
3. 'G' (S-045) 53mm x 20mm x 11mm MT Passed Repair complete.
4. 'L' (S-042) 75mm x 18mm x 11mm MT Passed Repair complete.
5. 'E' (N-045) 60mm x 10mm x 2mm (Welded August 2, 2011)
6. 'F' (E-045) 60mm x 10mm x 2mm (Welded August 2, 2011)
7. 'M' (W-042) 25mm x 6mm x 1mm MT Passed Repair complete
8. 'S' (S-041) 65mm x 10mm x 3mm MT Passed Excavated only.
9. 'W' (W-041) 75mm x 16mm x 13mm In Progress Excavated only.

Due to severity of the undercut that ranges from 1mm to 13mm, ABF has decided to fix the undercut by grinding them smooth, test with Magnetic Particle Testing and perform the repair. ABF welders were noted welding the undercut repairs using Shielded Metal Arc Welding (SMAW) with 1/8" diameter E7018H4R electrode implementing Caltrans approved Welding Procedure Specification ABF-WPS-D15-1000 Repair. The base metal was preheated to more than 300°F using propylene gas torch prior welding. During the repair welding, ABF QC Steve Jensen was noted monitoring the preheat and welding parameters of the two welders. ABF welder Jeremy Dolman was noted having a 110 amperes on a 1/8" diameter electrode while Richard Garcia was noted having 123 amperes on the same electrode.
