**DEPARTMENT OF TRANSPORTATION**

Contract #: 04-0120F4Cty: SF/ALA Rte: 80 PM: 13.2/13.9File #: 1.28**WELDING INSPECTION REPORT****Resident Engineer:** Siegenthaler, Peter**Address:** 333 Burma Road**City:** Oakland, CA 94607**Report No:** WIR-025408**Date Inspected:** 02-Aug-2011**Project Name:** SAS Superstructure**OSM Arrival Time:** 700**Prime Contractor:** American Bridge/Fluor Enterprises, a JV**OSM Departure Time:** 1730**Contractor:** American Bridge/Fluor Enterprises, a JV**Location:** Job Site**CWI Name:** See Below**CWI Present:** Yes No**Inspected CWI report:** Yes No N/A**Rod Oven in Use:** Yes No N/A**Electrode to specification:** Yes No N/A**Weld Procedures Followed:** Yes No N/A**Qualified Welders:** Yes No N/A**Verified Joint Fit-up:** Yes No N/A**Approved Drawings:** Yes No N/A**Approved WPS:** Yes No N/A**Delayed / Cancelled:** Yes No N/A**Bridge No:** 34-0006**Component:** Orthotropic Box Girder**Summary of Items Observed:**

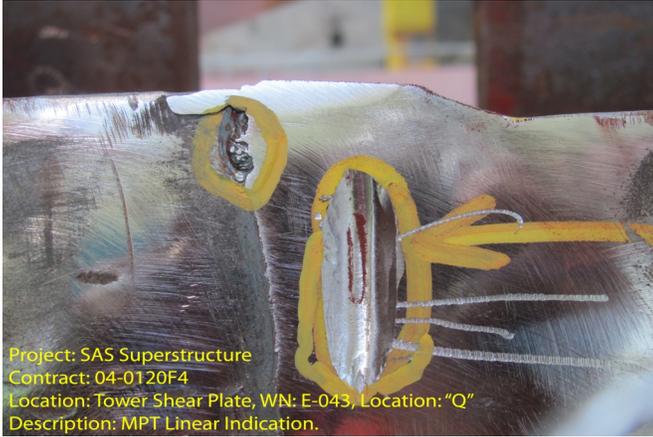
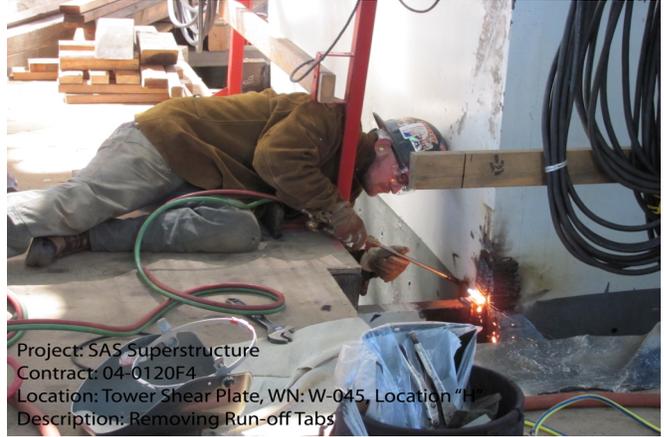
The digital photographs on page 3 of this report illustrate some of the work observed during this scheduled work date.
