DEPARTMENT OF TRANSPORTATION

Contract #: 04-0120F4Cty: SF/ALA Rte: 80 PM: 13.2/13.9File #: 1.28**WELDING INSPECTION REPORT****Resident Engineer:** Siegenthaler, Peter**Address:** 333 Burma Road**City:** Oakland, CA 94607**Report No:** WIR-025410**Date Inspected:** 04-Aug-2011**Project Name:** SAS Superstructure**OSM Arrival Time:** 700**Prime Contractor:** American Bridge/Fluor Enterprises, a JV**OSM Departure Time:** 1730**Contractor:** American Bridge/Fluor Enterprises, a JV**Location:** Job Site

CWI Name:	Steve Mc Connell and Steve Jensen			CWI Present:	Yes	No	
Inspected CWI report:	Yes	No	N/A	Rod Oven in Use:	Yes	No	N/A
Electrode to specification:	Yes	No	N/A	Weld Procedures Followed:	Yes	No	N/A
Qualified Welders:	Yes	No	N/A	Verified Joint Fit-up:	Yes	No	N/A
Approved Drawings:	Yes	No	N/A	Approved WPS:	Yes	No	N/A
				Delayed / Cancelled:	Yes	No	N/A
Bridge No:	34-0006			Component:	SAS Tower

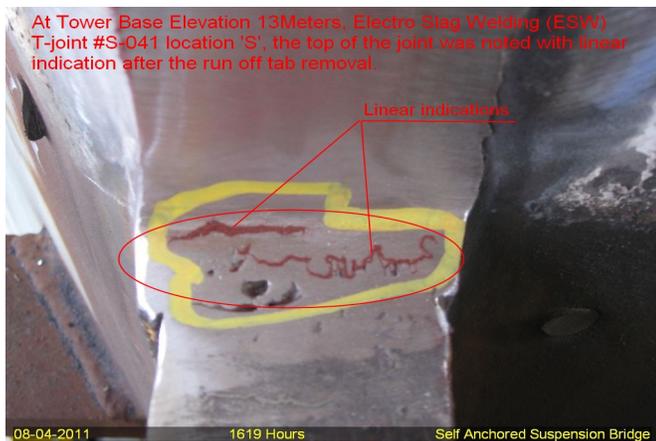
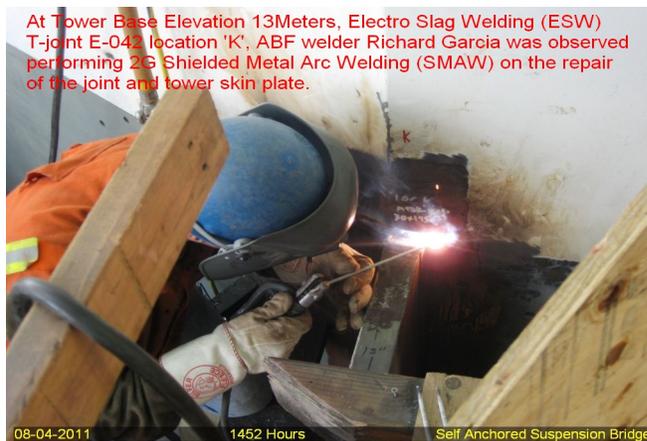
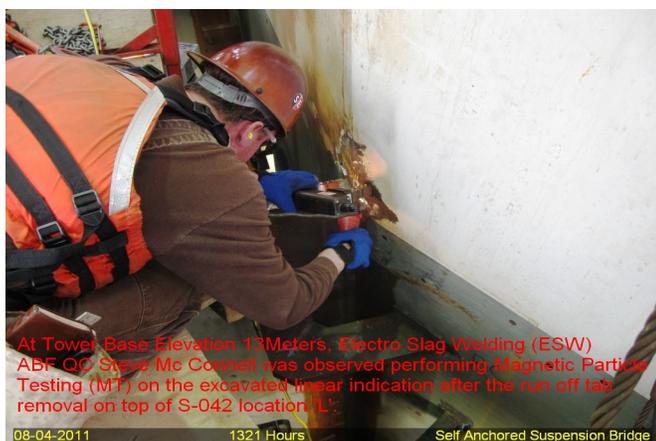
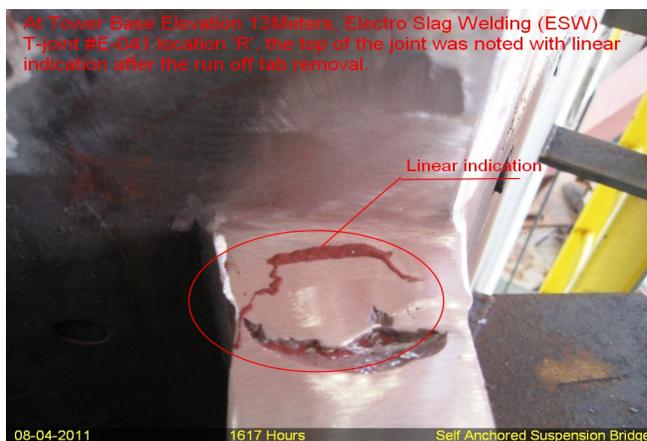
At Tower Base Elevation 13 Meters after the Electro Slag Welding (ESW) of eight (8) butt joints and twelve (12) T-joints, ABF personnel were noted continuing to grind/clean the removal of the run off tab welded on each joint. During the grinding and followed by Magnetic Particle Testing (MT), ABF QC Steve Mc Connell noted linear indications on top of the ESW welded T-joints. At first, ABF personnel were just using disc grinder to excavate and chase the linear indications but switched to carbon air arc gouging when they noted that the indications were wide and deep. ABF personnel excavated the linear indications using the carbon air gouging then followed up with a die grinder to make them smooth. The following ESW welded T-joints where the run off tab removed were noted with linear indications with some already excavated and tested with Magnetic Particle Testing (MT) by ABF QC Steve Mc Connell. The three (3) ESW welded T-joints that have been excavated and MT tested were also MT verified by this QA. Listed below are top of the ESW welded T-joints after the run off tab removal;

1. 'L' (S-042) 175mm x 30mm x 24mm MT Passed Repair pending.
2. 'K' (E-042) 195mm x 30mm x 25mm MT Passed Repair completed.
3. 'M' (W-042) 155mm x 40mm x 24mm MT Passed Repair pending.
4. 'E' (N-045) Excavation using carbon air arc gouging in progress.

5. 'F' (E-045) Excavation using carbon air arc gouging in progress.
6. 'G' (S-045) 50mm indication noted. To be excavated.
7. 'H' (W-045) 60mm indication noted. To be excavated.
8. 'W' (W-041) 50mm indication noted. To be excavated.
9. 'R' (E-041) 55mm indication noted. To be excavated.
10. 'S' (S-041) 50mm indication noted. To be excavated.

At Tower Base Elevation 13Meters, Electro Slag Weld (ESW) T-joint #E-042 location 'K', QA randomly observed ABF/JV qualified welder Richard Garcia perform CJP groove welding repair on top of the ESW welded T-joint. The linear indication that was originally noted on top of the ESW weld joint went as far as 25mm deep into the skin plate 'A' of the Tower West Shaft. The indication was first ground using a disc grinder then followed by a die grinder. ABF personnel switched to carbon air arc gouging when they noted that the indication was going deep. The final excavation profile was noted boat shape and was having an excavation dimension of 195mm long x 30mm wide x 25mm deep.

The welder was observed welding in the 2G (horizontal) position utilizing Shielded Metal Arc Welding (SMAW) with 1/8" diameter E7018H4R electrode implementing welding procedure ABF-WPS-D15-1001-Repairs. The repair excavation was preheated to more than 300 degrees Fahrenheit using propylene gas torch prior welding. During the shift, ABF QC Steve Mc Connell was noted monitoring the welder. Measured welding parameter during welding was 120 amperes on a 1/8" diameter E7018H4R electrode. Prior welding, ABF QC Steve Mc Connell was observed performing Magnetic Particle Testing (MT) on the excavated welding repair. This QA verified the repair excavation using the same MT test.

Other related activities noted during the shift include 45 degree bevel cutting on top of 80mm shear plate at the East side of the Tower. ABF welder Rory Hogan was noted cutting the bevel to 45 degree using an oxy-acetylene gas torch with the nozzle attached to a track mounted that was motor driven. Bevel cutting was still continuing at the end of the shift. All other personnel were noted grinding the top of the ESW weld joints after the run off tab removal.
