DEPARTMENT OF TRANSPORTATION

Contract #: 04-0120F4Cty: SF/ALA Rte: 80 PM: 13.2/13.9File #: 1.28**WELDING INSPECTION REPORT****Resident Engineer:** Siegenthaler, Peter**Address:** 333 Burma Road**City:** Oakland, CA 94607**Report No:** WIR-025471**Date Inspected:** 06-Aug-2011**Project Name:** SAS Superstructure**OSM Arrival Time:** 700**Prime Contractor:** American Bridge/Fluor Enterprises, a JV**OSM Departure Time:** 1530**Contractor:** American Bridge/Fluor Enterprises, a JV**Location:** Job Site

WELDING INSPECTION REPORT

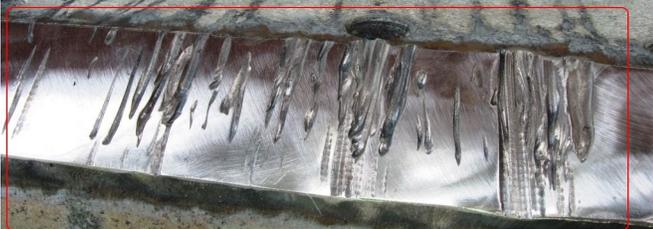
At Tower Base Elevation 13Meters, the top of 80mm shear plate at outer East was noted beveled and ground to 45 degree. This QA asked ABF QC John Pagliero if QC has already inspected the bevel preparation of the shear plate. QC responded that the top bevel preparation was acceptable. QA verified the top shear plate bevel preparation and noted that some part of the cut was rough to a maximum depth of 5mm. The required depth of bevel (39mm) was not also according to the drawing. Due to the observed discrepancy, this was brought to the attention of Lead QA Danny Reyes who also brought to the attention of ABF Superintendent Dan Ieraci. Mr. Dan Ieraci informed Mr. Reyes that if the bevel preparation was not satisfactory he will let his personnel rectify the bevel issue before they lay down the diaphragm.

At Tower Base Elevation 13Meters, the top of 80mm shear plate that was cut and beveled to 45 degree was noted roughly cut with measured depth of 5mm maximum.

Roughly cut bevel on top of outer East shear plate.

The bevel preparation of the outer East shear plate was brought to the attention of Lead QA Danny Reyes due to information from ABF QC John Pagliero that the top shear plate bevel preparation was acceptable despite the presence of deep notches on the cut surface.

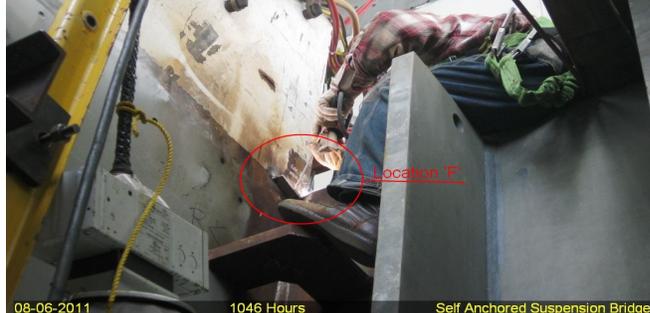
At Tower Base Elevation 13Meters, Electro Slag Welding (ESW) T-joint E-045 location 'F', QA randomly observed ABF/JV qualified welder Rory Hogan perform CJP groove welding repair on the top of the welded ESW due to ABF QC noted linear indications that propagated into the Tower skin plate. ABF welder has carbon arc and ground removed the indications then tested by QC Steve Mc Connell using Magnetic Particle Testing (MT) with affirmative result. The removal was verified by this QA and obtained same result. The welder was observed

welding in the 2G (horizontal) position utilizing Shielded Metal Arc Welding (SMAW) with 1/8" diameter E7018H4R electrode implementing welding procedure ABF-WPS-D15-1001-Repairs. The weld repair was preheated to more than 300 degree Fahrenheit using propylene gas torch prior welding. During the shift, ABF QC John Pagliero was noted monitoring the welder. Measured welding parameter during welding was 125 amperes on a 1/8" diameter E7018H4R electrode. At the end of the shift, 2G SMAW weld repair was completed and the welder was noted flush grinding the weld cover of the repair.

At Tower Base Elevation 13Meters, Electro Slag Welding (ESW) T-joint #E-045 location 'F', ABF welder Rory Hogan was observed performing 2G Shielded Metal Arc Welding (SMAW) welding repair.

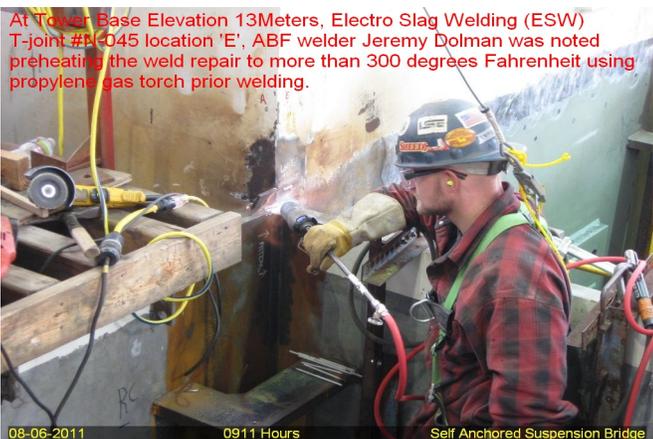
At Tower Base Elevation 13Meters, Electro Slag Welding (ESW) T-joint N-045 location 'E', QA randomly observed ABF/JV qualified welder Jeremy Dolman perform CJP groove welding repair on the top of the welded ESW due to ABF QC noted linear indications that propagated into the Tower skin plate. ABF welder has carbon arc and ground removed the indications then tested by QC Steve Mc Connell using Magnetic Particle Testing (MT) with affirmative result. The removal was verified by this QA and obtained same result. The welder was observed welding in the 2G (horizontal) position utilizing Shielded Metal Arc Welding (SMAW) with 1/8" diameter E7018H4R electrode implementing welding procedure ABF-WPS-D15-1001-Repairs. The weld repair was preheated to more than 300 degree Fahrenheit using propylene gas torch prior welding. During the shift, ABF QC John Pagliero was noted monitoring the welder. Measured welding parameter during welding was 110 amperes on a 1/8" diameter E7018H4R electrode. At the end of the shift, 2G SMAW weld repair was completed and the welder was noted flush grinding the weld cover of the repair.

At Tower Base Elevation 13Meters, Electro Slag Welding (ESW) T-joint #N-045 location 'E', ABF welder Jeremy Dolman was noted preheating the weld repair to more than 300 degrees Fahrenheit using propylene gas torch prior welding.

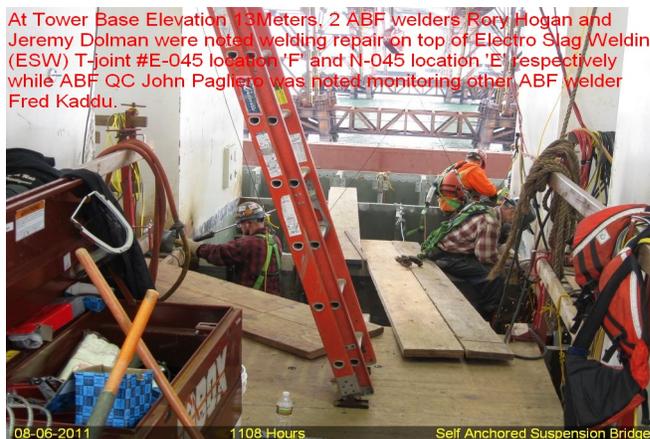
At Tower Base Elevation 13Meters, 2 ABF welders Rory Hogan and Jeremy Dolman were noted welding repair on top of Electro Slag Welding (ESW) T-joint #E-045 location 'F' and N-045 location 'E' respectively while ABF QC John Pagliero was noted monitoring other ABF welder Fred Kaddu.
