DEPARTMENT OF TRANSPORTATION

Contract #: 04-0120F4Cty: SF/ALA Rte: 80 PM: 13.2/13.9File #: 69.28**WELDING INSPECTION REPORT****Resident Engineer:** Siegenthaler, Peter**Address:** 333 Burma Road**City:** Oakland, CA 94607**Report No:** WIR-025474**Date Inspected:** 14-Jul-2011**Project Name:** SAS Superstructure**OSM Arrival Time:** 700**Prime Contractor:** American Bridge/Fluor Enterprises, a JV**OSM Departure Time:** 1900**Contractor:** Zhenhua Port Machinery Company, Ltd (ZPMC), Changxing Island **Location:** Shanghai, China**CWI Name:** An Qing Xiang**CWI Present:** Yes No**Inspected CWI report:** Yes No N/A**Rod Oven in Use:** Yes No N/A**Electrode to specification:** Yes No N/A**Weld Procedures Followed:** Yes No N/A**Qualified Welders:** Yes No N/A**Verified Joint Fit-up:** Yes No N/A**Approved Drawings:** Yes No N/A**Approved WPS:** Yes No N/A**Delayed / Cancelled:** Yes No N/A**Bridge No:** 34-0006**Component:** OBG**Summary of Items Observed:**

OBG TA YARD, SEGMENT 14W

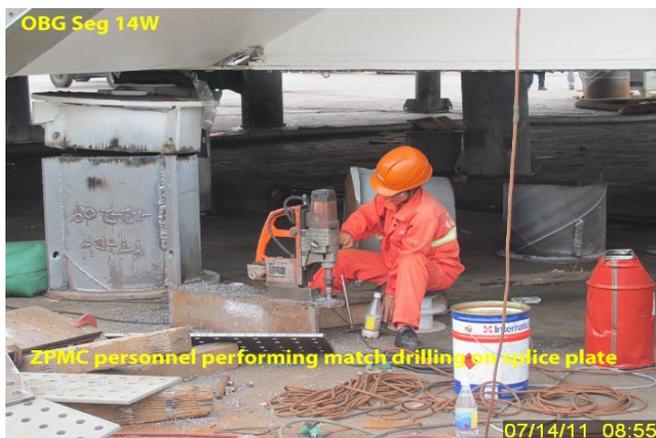
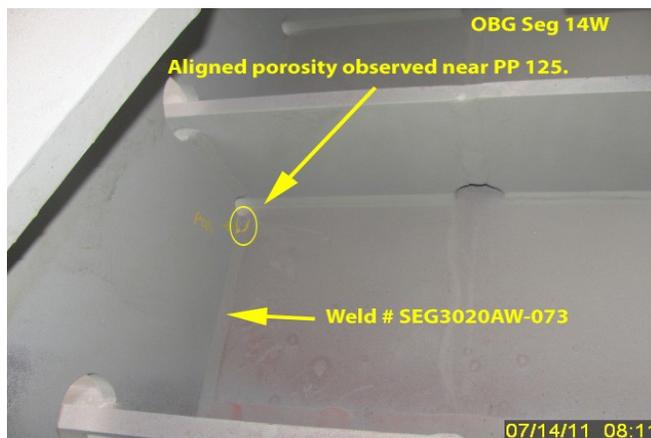
During random in process inspection this QA Inspector observed that ZPMC personnel were performing match

drilling on the splice plate of OBG Segment 14W. For more details please see attached photograph.

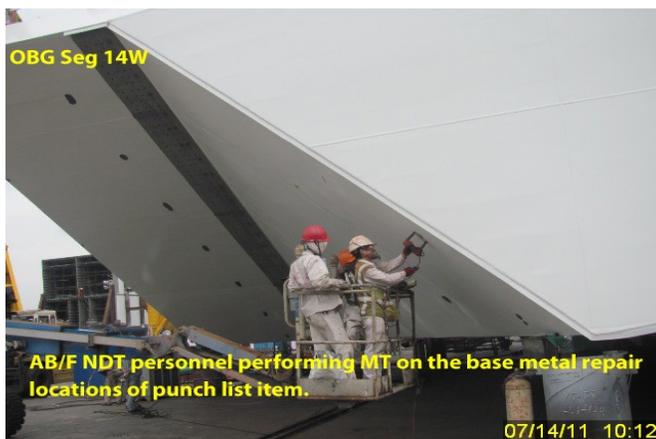
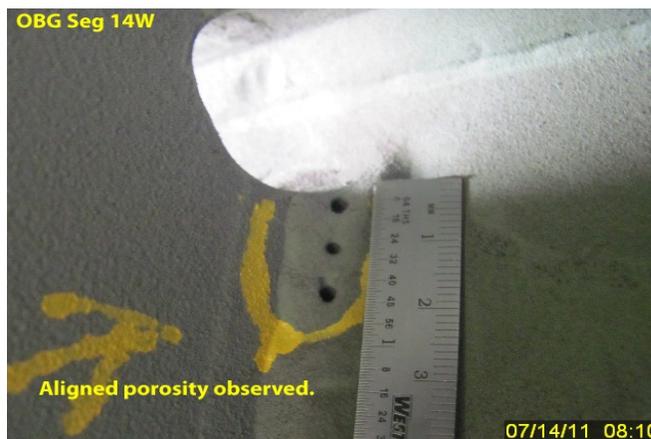
During random in process inspection this QA Inspector observed aligned porosity on weld joint SEG3020AW-073 near PP 125. This issue was discussed with ZPMC CWI Mr. An Qing Xiang. ZPMC CWI Mr. An Qing Xiang informed this QA that ZPMC will perform repair with comply to contract documents. For more details please see attached photograph.
