DEPARTMENT OF TRANSPORTATION

Contract #: 04-0120F4Cty: SF/ALA Rte: 80 PM: 13.2/13.9File #: 99.28**WELDING INSPECTION REPORT****Resident Engineer:** Siegenthaler, Peter**Address:** 333 Burma Road**City:** Oakland, CA 94607**Report No:** WIR-025512**Date Inspected:** 30-Jul-2011**Project Name:** SAS Superstructure**OSM Arrival Time:** 700**Prime Contractor:** American Bridge/Fluor Enterprises, a JV**OSM Departure Time:** 1900**Contractor:** Zhenhua Port Machinery Company, Ltd (ZPMC), Changxing Island **Location:** Shanghai**CWI Name:****CWI Present:**

Bridge No: 34-0006**Component:** OBG**Summary of Items Observed:**

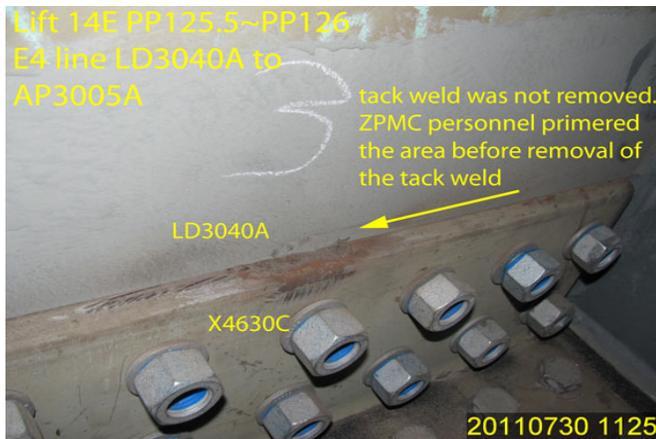
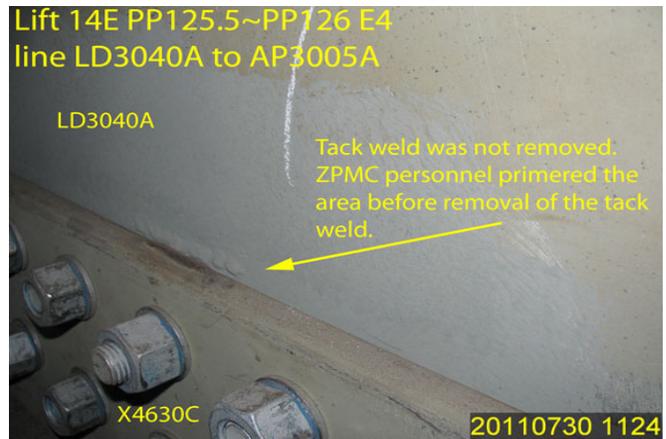
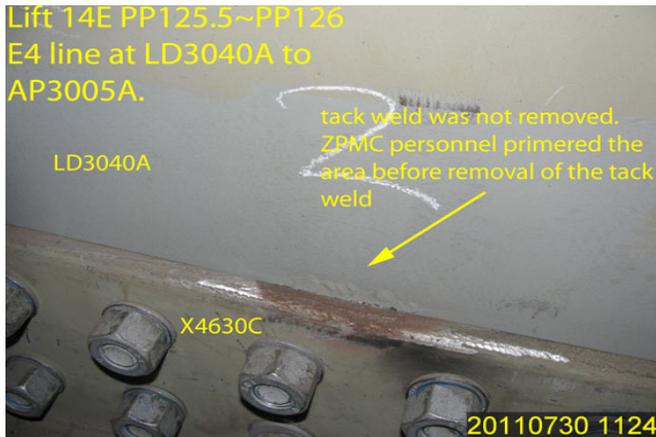
Description of Incident: During the Quality Assurance (QA) daily observation of the OBG High Strength Bolting, this QA Inspector discovered the following issues for areas with high strength bolts installed on this project:

- Lift 14E line E4 between PP125.5 and PP126.
- Three tacks weld connecting connection plate X4630C to LD3040A at AP3005A were not removed.
- Tack weld and adjoining area were primered prior to removal and Magnetic Particle testing of tack weld area. 1.
