Contract #: 04-0120F4Cty: SF/ALA Rte: 80 PM: 13.2/13.9File #: 99.28**WELDING INSPECTION REPORT****Resident Engineer:** Siegenthaler, Peter**Address:** 333 Burma Road**City:** Oakland, CA 94607**Report No:** WIR-025516**Date Inspected:** 25-Jul-2011**Project Name:** SAS Superstructure**OSM Arrival Time:** 700**Prime Contractor:** American Bridge/Fluor Enterprises, a JV**OSM Departure Time:** 1900**Contractor:** Zhenhua Port Machinery Company, Ltd (ZPMC), Changxing Island **Location:** Shanghai**CWI Name:****CWI Present:**

**Bridge No:** 34-0006**Component:** OBG**Summary of Items Observed:**

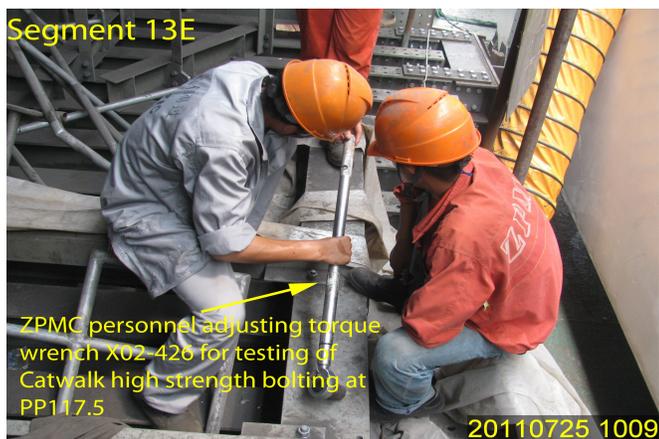
This QA Inspector witnessed the final bolt tension verification on bolts connecting the Catwalk from PP117.5 to PP124.5, I-rib stiffeners from PP121~PP121.5 between E3 and E4. The QA Inspector verified the bolt tension on a random basis and the results appeared to be in general compliance. The Inspection was performed against Notification No. 00709 dated July 25, 2011.

The bolt sizes used were M16 x 50 RC Lot # DHGM160004 and the final torque value established was 200 N-m. The Manual Torque wrench used was Serial No. X02-426.

The bolt sizes used were M27x110 RC Lot# DHGM270040 and the final torque value established was 650 N-m. The Manual Torque wrench used was X02-606.
