DEPARTMENT OF TRANSPORTATION

Contract #: 04-0120F4Cty: SF/ALA Rte: 80 PM: 13.2/13.9File #: 99.28**WELDING INSPECTION REPORT****Resident Engineer:** Siegenthaler, Peter**Address:** 333 Burma Road**City:** Oakland, CA 94607**Report No:** WIR-025551**Date Inspected:** 02-Jul-2011**Project Name:** SAS Superstructure**OSM Arrival Time:** 1500**Prime Contractor:** American Bridge/Fluor Enterprises, a JV**OSM Departure Time:** 300**Contractor:** Zhenhua Port Machinery Company, Ltd (ZPMC) Changxing Island **Location:** Shanghai, China

OBG 13AW

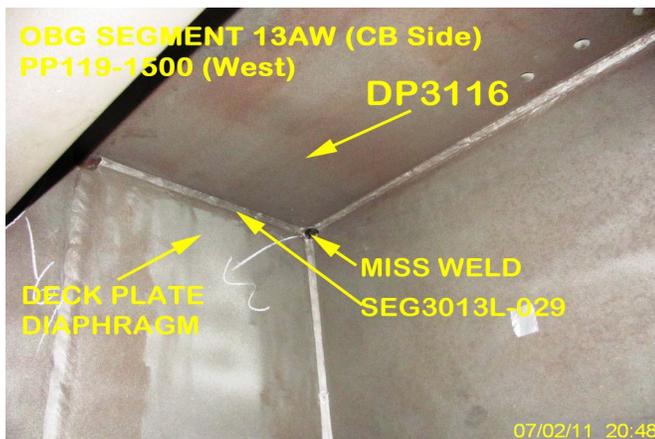
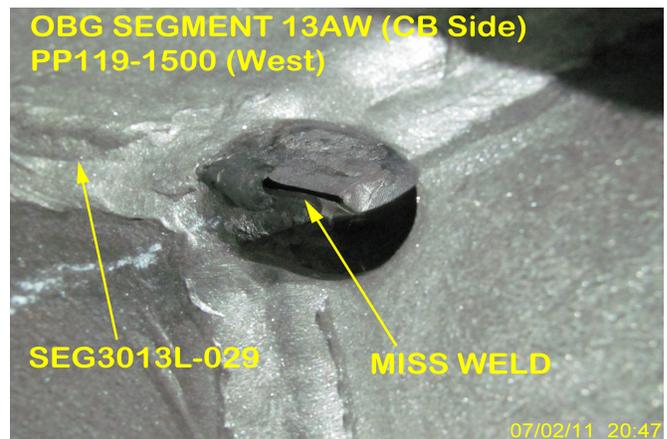
During the Quality Assurance Inspection of Visual testing (VT) of Post blast inspection of Deck Plate (DP3116) internal welds at PP119-1500 of the OBG 13AW [CB Side], this Quality Assurance Inspector (QA) discovered the Miss Weld measuring approximately 50 mm long on weld joint identified as SEG3013L-029 located on deck plate to deck plate diaphragm. The location is marked up for weld repair and was recorded on a weld map for future repair. For further information, please see the attached pictures below:
