**DEPARTMENT OF TRANSPORTATION**

Contract #: 04-0120F4Cty: SF/ALA Rte: 80 PM: 13.2/13.9File #: 69.28**WELDING INSPECTION REPORT****Resident Engineer:** Siegenthaler, Peter**Address:** 333 Burma Road**City:** Oakland, CA 94607**Report No:** WIR-025578**Date Inspected:** 05-Aug-2011**Project Name:** SAS Superstructure**OSM Arrival Time:** 1900**Prime Contractor:** American Bridge/Fluor Enterprises, a JV**OSM Departure Time:** 700**Contractor:** Zhenhua Port Machinery Company, Ltd (ZPMC), Changxing Island **Location:** Shanghai, China**CWI Name:** N/A**CWI Present:** Yes No**Inspected CWI report:** Yes No N/A**Rod Oven in Use:** Yes No N/A**Electrode to specification:** Yes No N/A**Weld Procedures Followed:** Yes No N/A**Qualified Welders:** Yes No N/A**Verified Joint Fit-up:** Yes No N/A**Approved Drawings:** Yes No N/A**Approved WPS:** Yes No N/A**Delayed / Cancelled:** Yes No N/A**Bridge No:** 34-0006**Component:** OBG**Summary of Items Observed:**

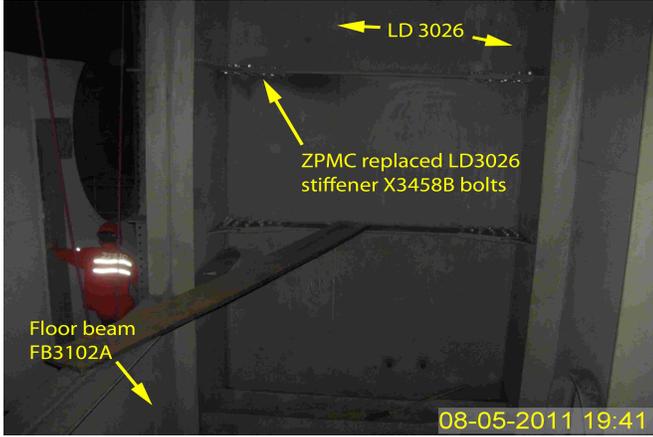
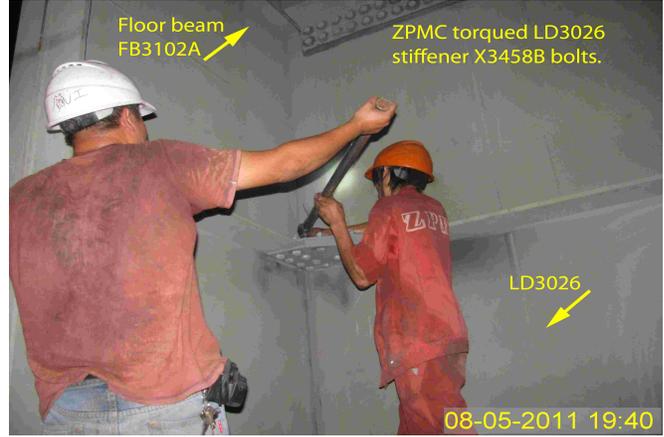
Item 2: On August 3 and August 4 this QA Inspector performed random visual inspections as ZPMC performed torque verifications of "Triangle Plate" bolting at segment 13AE longitudinal diaphragm LD3026 stiffener X3458B near PP117. Two bolts rotated when ZPMC applied the torque. ZPMC workers determined the nuts appeared to be jammed onto the bolts and the only way they could be removed was to cut the bolts or nuts. On August 3 ZPMC QC Inspector Mr. Xu Jin Long informed this QA Inspector that dayshift personnel would remove the damaged bolt, a new bolt, nut and washer would be installed and this bolted connection would be ready for torque verifications on August 4 at 2000 hours. On August 4 ZPMC QC Inspector Mr. Xu Jin Long informed this QA Inspector that dayshift personnel had removed the damaged bolts and new bolts, nuts and washers had been installed and these bolted connections would be ready for torque verifications on August 5 at 2000 hours. At around 2000 hours on August 5 (today) ZPMC QC Inspector Mr. Xu Jin Long informed this QA Inspector that ZPMC personnel have replaced the defective bolts and ZPMC workers are ready to use torque wrench serial number X02-666 which is adjusted to approximately 380 nM. to perform final tension verification of bolted

connections of this same bolted connection. ZPMC QC informed this QA Inspector that RC Set No. DHGM220140 – M22x80 – required torque 380 nM. for tensioning from the nut end have been installed at this location. This QA Inspector observed the new bolts and all the other bolts on this splice connection have been tightened to 308 nM. Items observed appear to comply with project specifications.
