Contract #: 04-0120F4Cty: SF/ALA Rte: 80 PM: 13.2/13.9File #: 69.28**WELDING INSPECTION REPORT****Resident Engineer:** Siegenthaler, Peter**Address:** 333 Burma Road**City:** Oakland, CA 94607**Report No:** WIR-025579**Date Inspected:** 04-Aug-2011**Project Name:** SAS Superstructure**OSM Arrival Time:** 1900**Prime Contractor:** American Bridge/Fluor Enterprises, a JV**OSM Departure Time:** 700**Contractor:** Zhenhua Port Machinery Company, Ltd (ZPMC), Changxing Island **Location:** Shanghai, China

WELDING INSPECTION REPORT

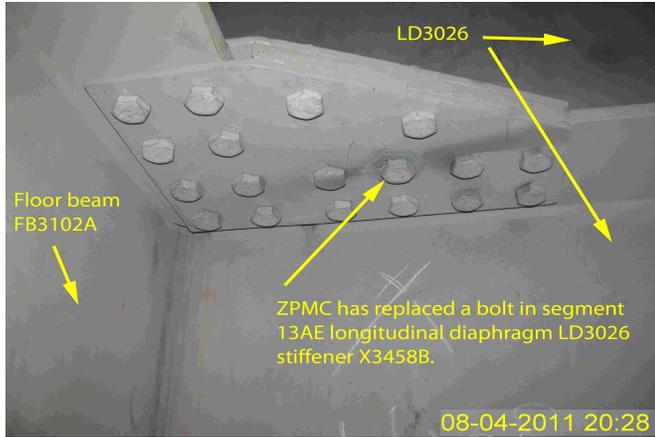
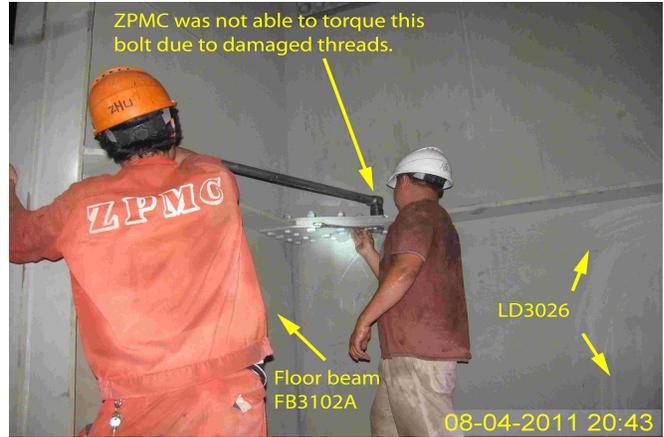
Item 2: Yesterday, August 3, this QA Inspector performed random visual inspections as ZPMC performed torque verifications of segment 13AE "Triangle Plates" on longitudinal diaphragm LD3026 stiffener X3458B bolts near PP117. One bolt rotated when ZPMC applied torque at this location. ZPMC workers could not tighten this bolt then ZPMC used an air operated wrench to attempt to remove this nut from the bolt and the nut appears to be jammed onto the bolt. ZPMC QC Inspector Mr. Xu Jin Long informed this QA Inspector that dayshift personnel would remove the damaged bolt and a new bolt, nut and washer would be installed. At around 2000 hours ZPMC QC Inspector Mr. Xu Jin Long informed this QA Inspector that ZPMC personnel have replaced the defective bolt and ZPMC workers are ready to use torque wrench serial number X02-666 which is adjusted to approximately 380 nM. to perform final tension verification of bolted connections of this same bolted connection. ZPMC QC informed this QA Inspector that RC Set No. DHGM220140 – M22x80 – required torque 380 nM. for tensioning from the nut end have been installed at this location. This QA Inspector observed the new bolt appears to have been tightened to 308 nM. This QA Inspector informed ZPMC QC Inspector Mr. Xu Jin Long that all the other

bolts on this splice connection should be verified for adequate tightness. This QA Inspector observed two of the bolts appeared to rotate and one other bolt rotated and it did not appear to tighten. ZPMC QC Inspector Mr. Xu Jin Long said that ZPMC will replace this bolt and they will torque this splice connection tomorrow night. See the photographs below for additional information.
