**DEPARTMENT OF TRANSPORTATION**

Contract #: 04-0120F4Cty: SF/ALA Rte: 80 PM: 13.2/13.9File #: 69.28**WELDING INSPECTION REPORT****Resident Engineer:** Siegenthaler, Peter**Address:** 333 Burma Road**City:** Oakland, CA 94607**Report No:** WIR-025593**Date Inspected:** 26-Jul-2011**Project Name:** SAS Superstructure**OSM Arrival Time:** 700**Prime Contractor:** American Bridge/Fluor Enterprises, a JV**OSM Departure Time:** 1900**Contractor:** Zhenhua Port Machinery Company, Ltd (ZPMC), Changxing Island **Location:** Shanghai, China**CWI Name:** An Qing Xiang**CWI Present:** Yes No**Inspected CWI report:** Yes No N/A**Rod Oven in Use:** Yes No N/A**Electrode to specification:** Yes No N/A**Weld Procedures Followed:** Yes No N/A**Qualified Welders:** Yes No N/A**Verified Joint Fit-up:** Yes No N/A**Approved Drawings:** Yes No N/A**Approved WPS:** Yes No N/A**Delayed / Cancelled:** Yes No N/A**Bridge No:** 34-0006**Component:** OBG**Summary of Items Observed:**

SHIP # 19, OBG SEGMENT 14W

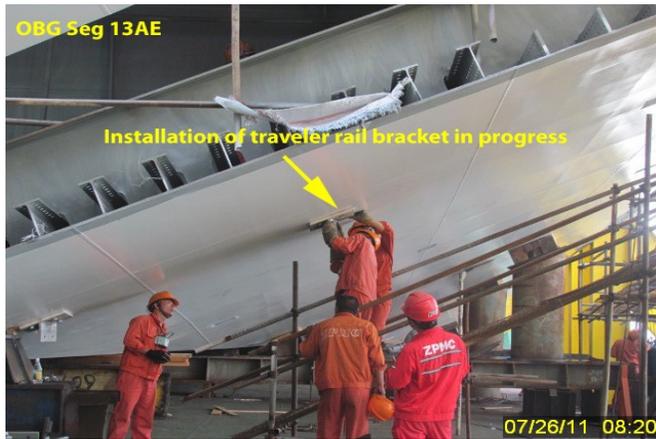
During random in process inspection this QA Inspector observed that ZPMC personnel were installing traveler rail bracket on Side Panel (SP) of OBG segment 13AE. See attached photograph for more details.

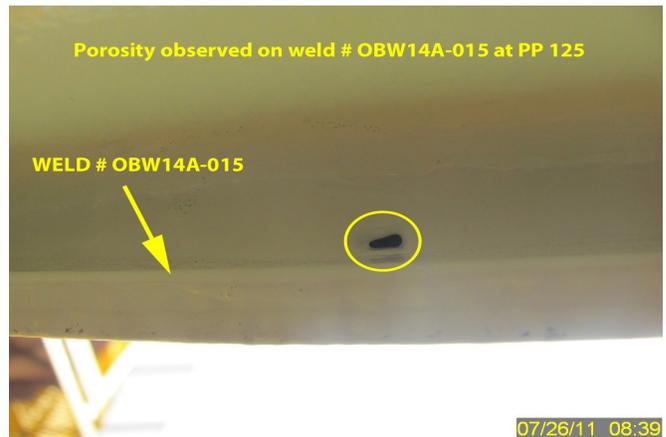
Porosity observed on weld joint OBW14A-015 joining drip plate to SP 3131A at PP 125 cable side.

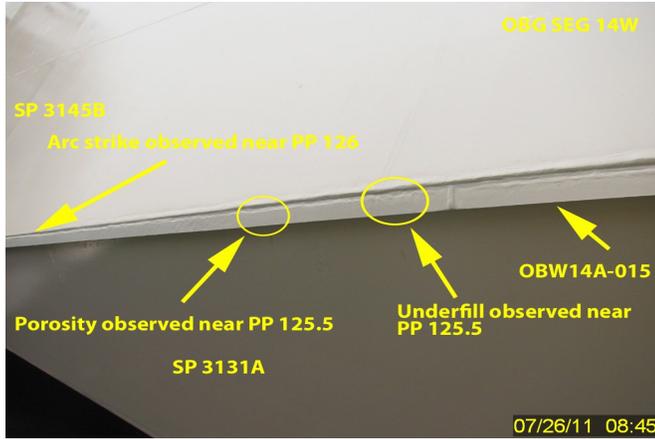
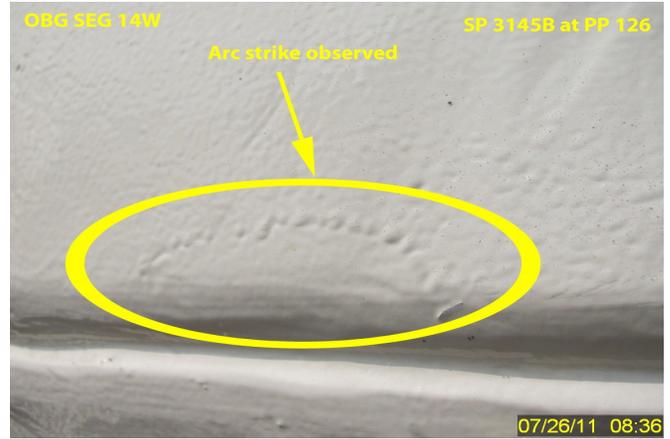
Underfill observed at two locations on weld joint OBW14A-015 joining drip plate to SP 3131A at PP 125.5 cable side.
