**DEPARTMENT OF TRANSPORTATION**

Contract #: 04-0120F4Cty: SF/ALA Rte: 80 PM: 13.2/13.9File #: 69.28**WELDING INSPECTION REPORT****Resident Engineer:** Siegenthaler, Peter**Address:** 333 Burma Road**City:** Oakland, CA 94607**Report No:** WIR-025595**Date Inspected:** 27-Jul-2011**Project Name:** SAS Superstructure**OSM Arrival Time:** 700**Prime Contractor:** American Bridge/Fluor Enterprises, a JV**OSM Departure Time:** 1900**Contractor:** Zhenhua Port Machinery Company, Ltd (ZPMC), Changxing Island **Location:** Shanghai, China**CWI Name:** An Qing Xiang**CWI Present:** Yes No**Inspected CWI report:** Yes No N/A**Rod Oven in Use:** Yes No N/A**Electrode to specification:** Yes No N/A**Weld Procedures Followed:** Yes No N/A**Qualified Welders:** Yes No N/A**Verified Joint Fit-up:** Yes No N/A**Approved Drawings:** Yes No N/A**Approved WPS:** Yes No N/A**Delayed / Cancelled:** Yes No N/A**Bridge No:** 34-0006**Component:** OBG**Summary of Items Observed:**

SHIP # 19, OBG SEGMENT 13AE

SHIP # 19, OBG SEGMENT 14W

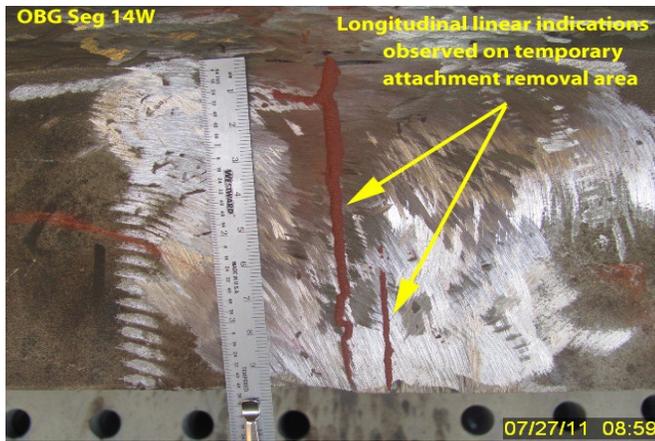
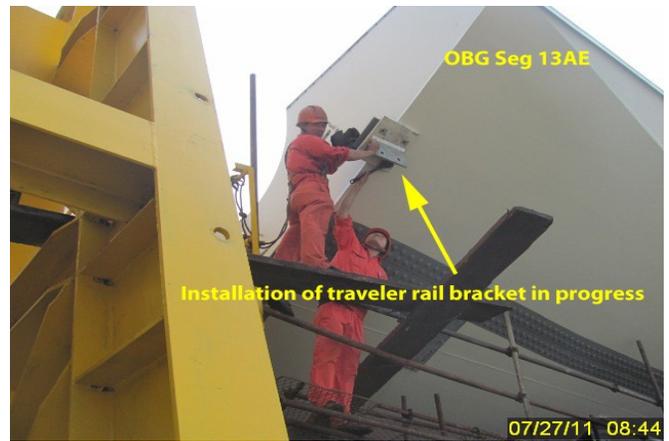
Longitudinal linear indications were observed on temporary attachment removal area on the stiffeners of top Anchorage plate (AP) 3023A at FL3 area of segment 14W during witness with AB/F Magnetic Particle Testing (MT) personnel. See attached photograph for more details.
