Contract #: 04-0120F4Cty: SF/ALA Rte: 80 PM: 13.2/13.9File #: 69.28**WELDING INSPECTION REPORT****Resident Engineer:** Siegenthaler, Peter**Address:** 333 Burma Road**City:** Oakland, CA 94607**Report No:** WIR-025612**Date Inspected:** 26-Jul-2011**Project Name:** SAS Superstructure**OSM Arrival Time:** 700**Prime Contractor:** American Bridge/Fluor Enterprises, a JV**OSM Departure Time:** 1900**Contractor:** Zhenhua Port Machinery Company, Ltd (ZPMC), Changxing Island **Location:** Shanghai, China**CWI Name:** Lu Hua Jie**CWI Present:** Yes No**Inspected CWI report:** Yes No N/A**Rod Oven in Use:** Yes No N/A**Electrode to specification:** Yes No N/A**Weld Procedures Followed:** Yes No N/A**Qualified Welders:** Yes No N/A**Verified Joint Fit-up:** Yes No N/A**Approved Drawings:** Yes No N/A**Approved WPS:** Yes No N/A**Delayed / Cancelled:** Yes No N/A**Bridge No:** 34-0006**Component:** OBG**Summary of Items Observed:**

OBG 14 EAST

OBG SEGMENT 13AW

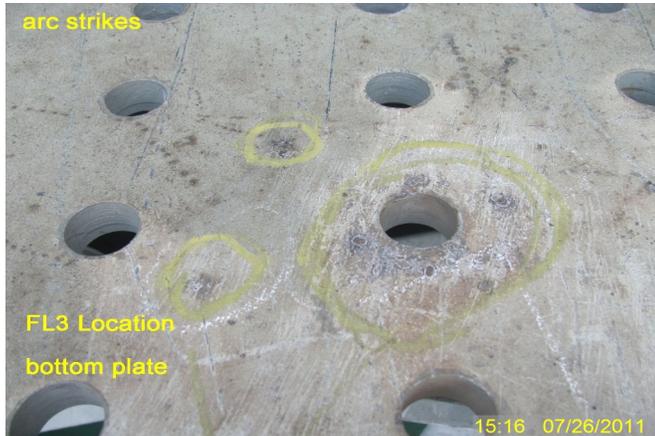
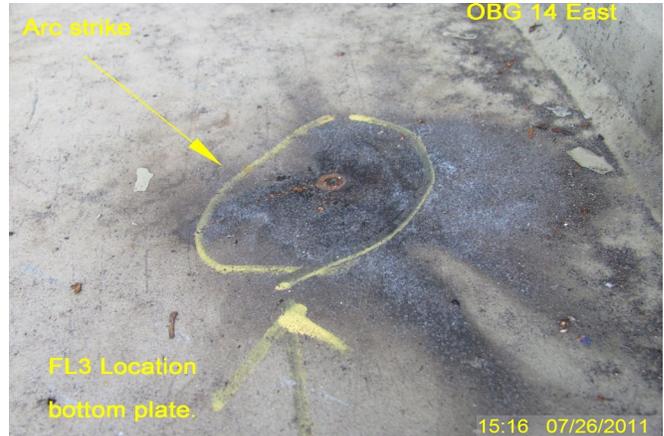
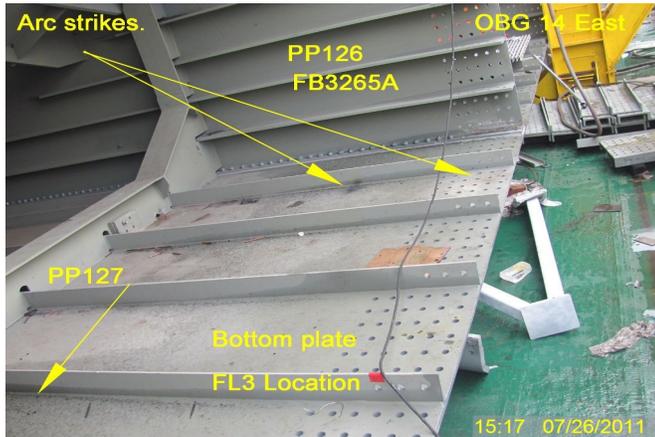
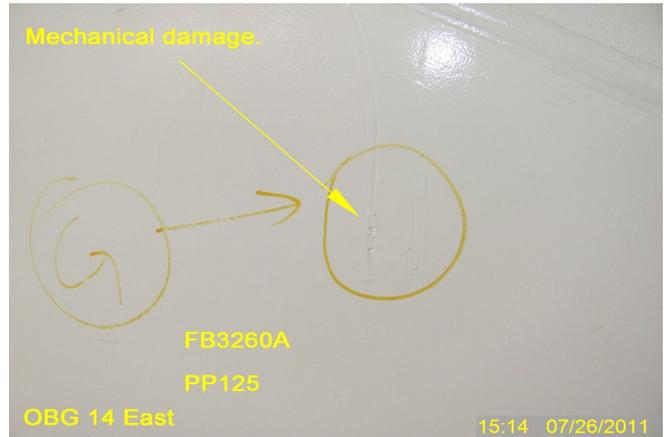
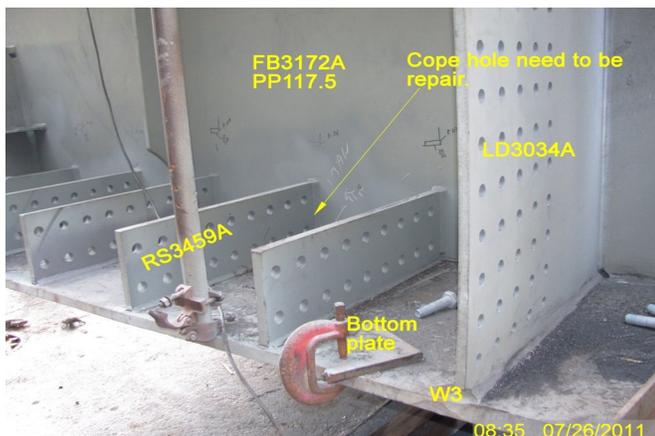
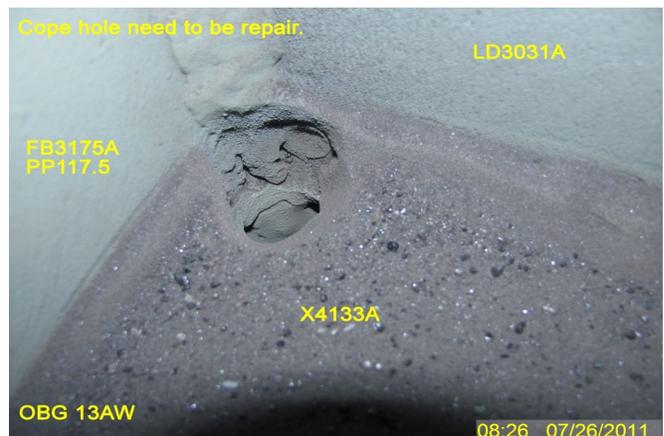
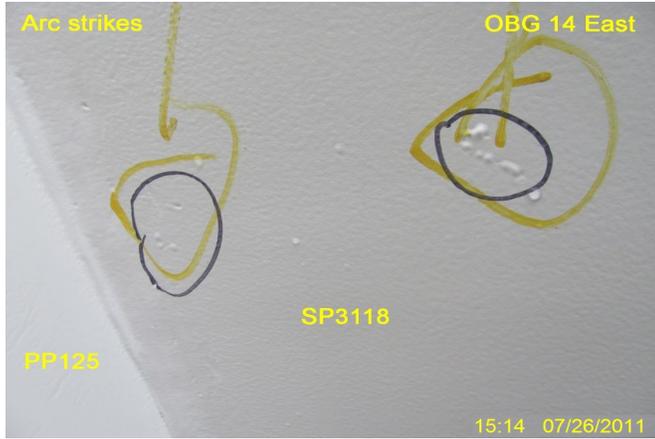
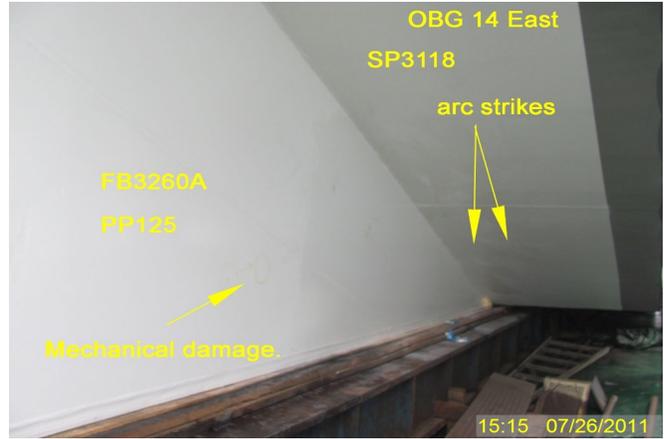
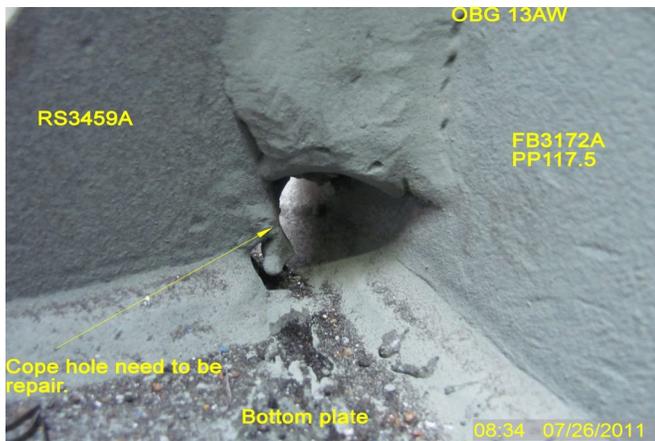
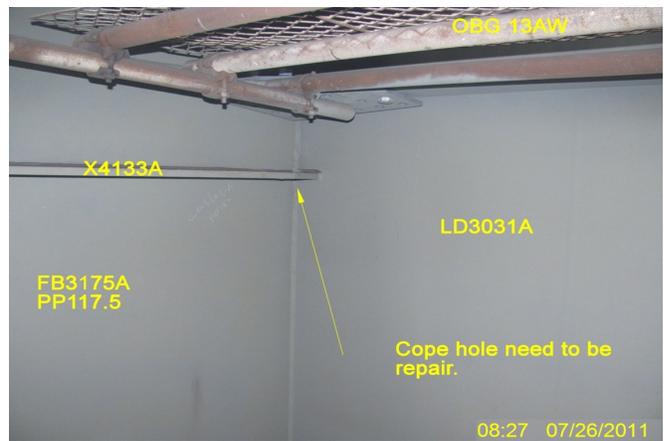
This QA Inspector performed random visual inspection on edge panel, floor beam, side plate (exterior) and FL 3 location of OBG segment 14 east on cross beam side, during the visual inspection this QA Inspector various arc strikes and mechanical damage like discontinuity.

This QA Inspector performed random visual Inspection for verification of the cope holes in internal section of OBG 13AW . During the verification this QA Inspector observed some cope holes are not acceptable that need to be repaired by grinding and welding.
