DEPARTMENT OF TRANSPORTATION

Quality Assurance and Source Inspection

Contract #: 04-0120F4Cty: SF/ALA Rte: 80 PM: 13.2/13.9File #: 69.28**WELDING INSPECTION REPORT****Resident Engineer:** Siegenthaler, Peter**Address:** 333 Burma Road**City:** Oakland, CA 94607**Report No:** WIR-025645**Date Inspected:** 03-Aug-2011**Project Name:** SAS Superstructure**OSM Arrival Time:** 1900**Prime Contractor:** American Bridge/Fluor Enterprises, a JV**OSM Departure Time:** 700**Contractor:** Zhenhua Port Machinery Company, Ltd (ZPMC), Changxing Island **Location:** Shanghai, China

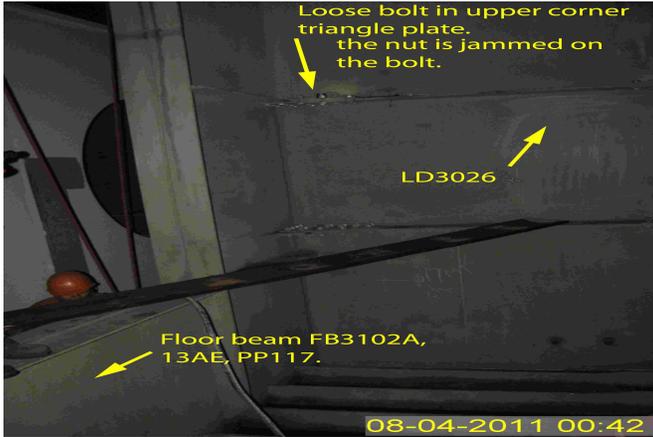
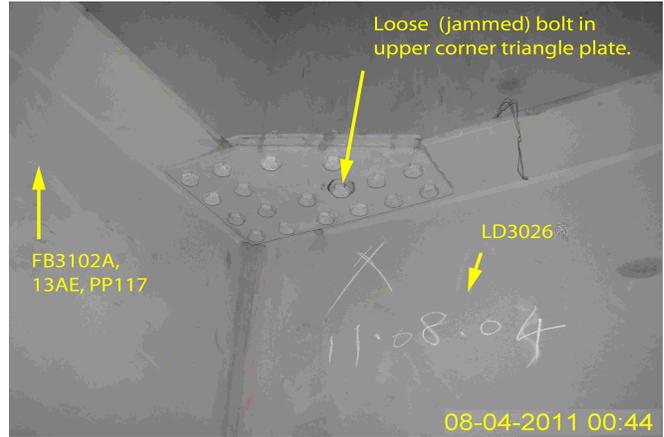
Item 1: Triangle plates between LD3025A stiffeners X3458D, X3458F and X3459A near PP119.65 / PP120; between LD3026A stiffeners X3458F, X3458D and X3459A near PP119.65 / PP120, between LD3025 stiffeners X3458B, X3458C and X3458J near PP117 / PP118 and between LD3026 stiffeners X3458J, X3458C and X3458B near PP117 / PP118. ZPMC workers adjusted the torque wrench to approximately 390 nM. and ZPMC workers tested two fasteners (10%) on each of the plate connections. RC Set No. DHGM220140 – M22x80 – required torque 380 nM. for tensioning from the nut end. One bolt on stiffener plate X3458B, near PP117, rotated when ZPMC applied the torque. ZPMC workers used an air operated wrench to attempt to remove this nut from the bolt and the nut appears to be jammed onto the bolt. Due to the late hour and the lack of grinding or cutting equipment, ZPMC workers decided to request that dayshift workers remove and replace this bolt. All other bolted connections appear to comply with project specifications. See the photographs below for additional information.

5, 124 and 124.5. ZPMC QC Inspector Mr. Xu Jia Long informed this QA Inspector that the following bolting materials had been installed: RC Set No. DHGM220105 – M22x65 required torque 380 nM. for tensioning from the nut end and RC Set No. DHGM220134 – M22x55 required torque 387 nM. for tensioning from the nut end. ZPMC workers adjusted the torque wrench to approximately 390 nM. and they tested one fastener (10%) on each of the plate connections. Items observed appear to comply with project specifications.
