**DEPARTMENT OF TRANSPORTATION**

Contract #: 04-0120F4Cty: SF/ALA Rte: 80 PM: 13.2/13.9File #: 1.28**WELDING INSPECTION REPORT****Resident Engineer:** Siegenthaler, Peter**Address:** 333 Burma Road**City:** Oakland, CA 94607**Report No:** WIR-025657**Date Inspected:** 08-Aug-2011**Project Name:** SAS Superstructure**OSM Arrival Time:** 700**Prime Contractor:** American Bridge/Fluor Enterprises, a JV**OSM Departure Time:** 1730**Contractor:** American Bridge/Fluor Enterprises, a JV**Location:** Job Site

**Bridge No:** 34-0006**Component:** SAS Tower**Summary of Items Observed:**

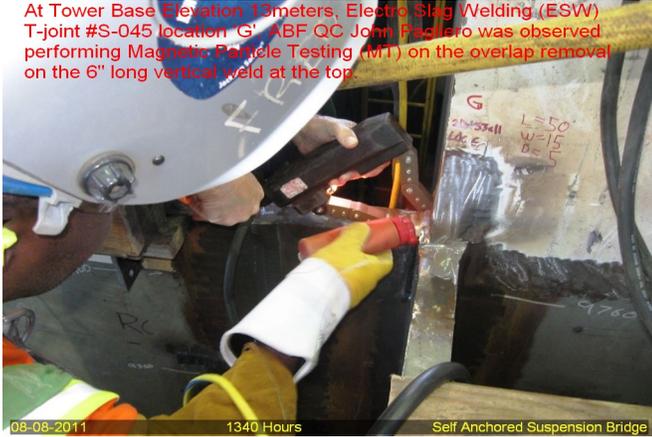
At Tower Base Elevation 13Meters, Electro Slag Welding (ESW) T-joint S-045 location 'G', QA randomly observed ABF/JV qualified welder Fred Kaddu perform CJP groove welding repair on the welded cover due to ABF QC noted overlap at approximately Y=9630mm to Y=9780mm. ABF welder has ground removed the overlap then tested by ABF QC John Pagliero using Magnetic Particle Testing (MT) with affirmative result. The removal was verified by this QA and obtained same result. The welder was observed welding in the 3G (vertical) position utilizing Shielded Metal Arc Welding (SMAW) with 5/32" diameter E7018H4R electrode implementing welding procedure ABF-WPS-D15-1000-Repairs. The weld cover repair was preheated to more than 300 degree Fahrenheit using propylene gas torch prior welding. During the shift, ABF QC John Pagliero was noted monitoring the welder. Measured welding parameter during welding was 180 amperes on a 5/32" diameter E7018H4R electrode. At the end of the shift, 3G SMAW weld cover repair was completed and other ABF personnel was noted smooth grinding the weld cover of the joint after welding.

At Tower Base Elevation 13meters, Electro Slag Welding (ESW) T-joint #S-045 location 'G', ABF QC John Pagliero was observed performing Magnetic Particle Testing (MT) on the overlap removal on the 6" long vertical weld at the top.

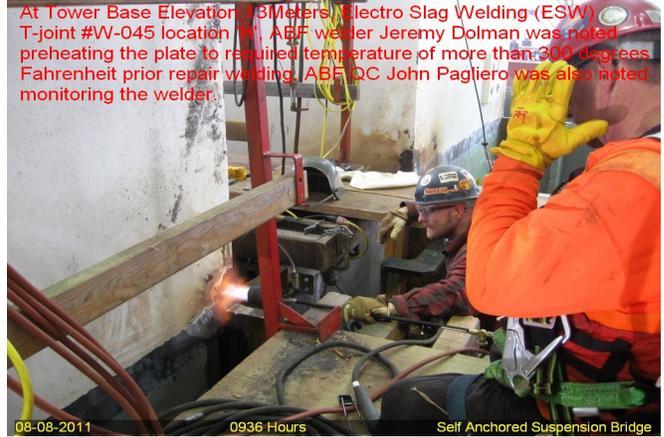
At Tower Base Elevation 13Meters, Electro Slag Welding (ESW) T-joint #W-045 location 'U', ABF welder Jeremy Dolman was noted preheating the plate to required temperature of more than 300 degrees Fahrenheit prior repair welding. ABF QC John Pagliero was also noted monitoring the welder.
