**DEPARTMENT OF TRANSPORTATION**

Contract #: 04-0120F4Cty: SF/ALA Rte: 80 PM: 13.2/13.9File #: 69.28**WELDING INSPECTION REPORT****Resident Engineer:** Siegenthaler, Peter**Address:** 333 Burma Road**City:** Oakland, CA 94607**Report No:** WIR-025700**Date Inspected:** 01-Jul-2011**Project Name:** SAS Superstructure**OSM Arrival Time:** 1900**Prime Contractor:** American Bridge/Fluor Enterprises, a JV**OSM Departure Time:** 700**Contractor:** Zhenhua Port Machinery Company, Ltd (ZPMC), Changxing Island **Location:** Shanghai, China**CWI Name:** See below**CWI Present:** Yes No**Inspected CWI report:** Yes No N/A**Rod Oven in Use:** Yes No N/A**Electrode to specification:** Yes No N/A**Weld Procedures Followed:** Yes No N/A**Qualified Welders:** Yes No N/A**Verified Joint Fit-up:** Yes No N/A**Approved Drawings:** Yes No N/A**Approved WPS:** Yes No N/A**Delayed / Cancelled:** Yes No N/A**Bridge No:** 34-0006**Component:** OBG**Summary of Items Observed:**

# WELDING INSPECTION REPORT

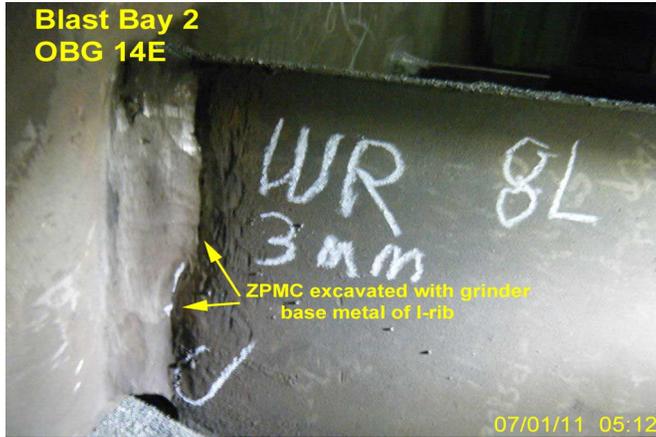
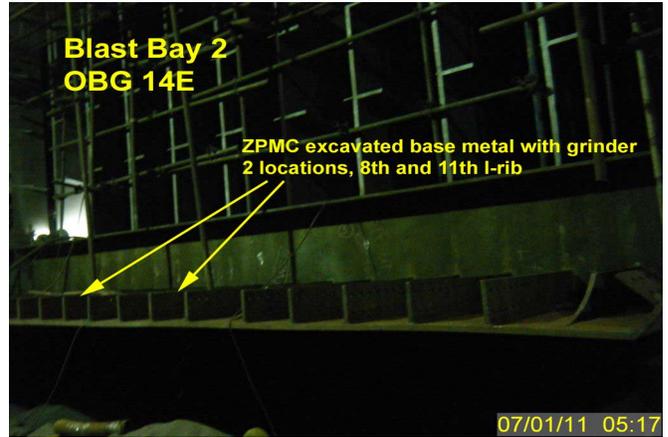
This Caltrans QA Inspector performed a post-blast visual inspection, request number 7255A, of the interior surface and internal components of Lift 14E, anchor plate ceiling and vertical floor beams. Surface defects and base metal surface irregularities that required grinding were marked up with colored chalk, and weld defects that require welding were taped with gray masking tape for repair after the coating has been applied. ZPMC QC and ABF inspection personnel were present during the inspection and informed of QA findings. The blast inspection was accepted, with salt testing and profile testing results posted below. (see photos for weld rejects)
