**DEPARTMENT OF TRANSPORTATION**

Contract #: 04-0120F4Cty: SF/ALA Rte: 80 PM: 13.2/13.9File #: 99.28**WELDING INSPECTION REPORT****Resident Engineer:** Siegenthaler, Peter**Address:** 333 Burma Road**City:** Oakland, CA 94607**Report No:** WIR-025730**Date Inspected:** 04-Jul-2011**Project Name:** SAS Superstructure**OSM Arrival Time:** 1500**Prime Contractor:** American Bridge/Fluor Enterprises, a JV**OSM Departure Time:** 300**Contractor:** Zhenhua Port Machinery Company, Ltd (ZPMC) Chanxing Island**Location:** Shanghai, China**CWI Name:****CWI Present:**

**Bridge No:** 34-0006**Component:** OBG 13BE, 13AW**Summary of Items Observed:**

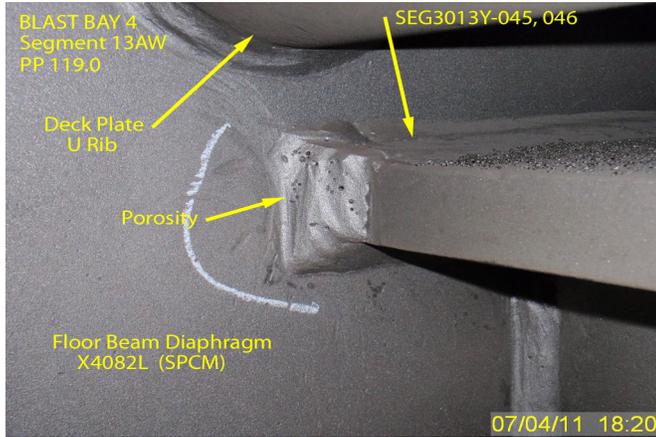
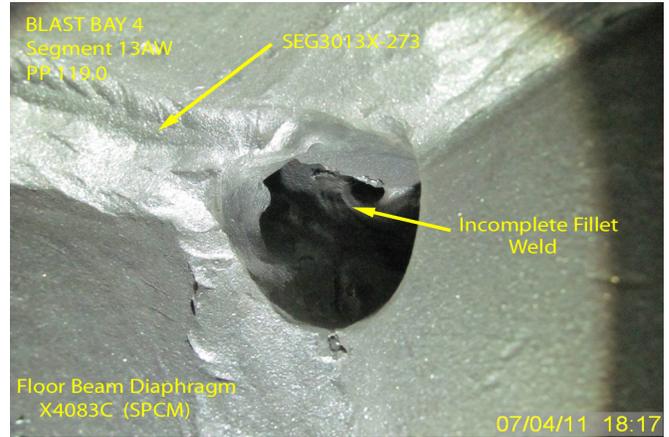
During the Quality Assurance Visual Testing (VT) of Post blast inspection; this QA inspector performed a visual inspection on internal box surfaces. The areas that were presented to this QA inspector were between PP 119+1500 to PP 119-1500 from W2 to W5, PP 118.0 to PP 119-1500 from W3 to W4, internal areas inspected from deck plate to one meter below top of floor beam. This QA inspector found multiple areas requiring additional grinding, and cleaning. The areas that only required grinding were marked for repair, and the ABF QC was notified of the locations marked. The information was transferred to the appropriate weld maps and post blast inspection report and sent to the appropriate personnel for tracking and punch list.
