DEPARTMENT OF TRANSPORTATION

Contract #: 04-0120F4Cty: SF/ALA Rte: 80 PM: 13.2/13.9File #: 99.28**WELDING INSPECTION REPORT****Resident Engineer:** Siegenthaler, Peter**Address:** 333 Burma Road**City:** Oakland, CA 94607**Report No:** WIR-025731**Date Inspected:** 05-Jul-2011**Project Name:** SAS Superstructure**OSM Arrival Time:** 1500**Prime Contractor:** American Bridge/Fluor Enterprises, a JV**OSM Departure Time:** 300**Contractor:** Zhenhua Port Machinery Company, Ltd (ZPMC) Chanxing Island**Location:** Shanghai, China**CWI Name:****CWI Present:**

Bridge No: 34-0006**Component:** OBG 13BE, 14W**Summary of Items Observed:**

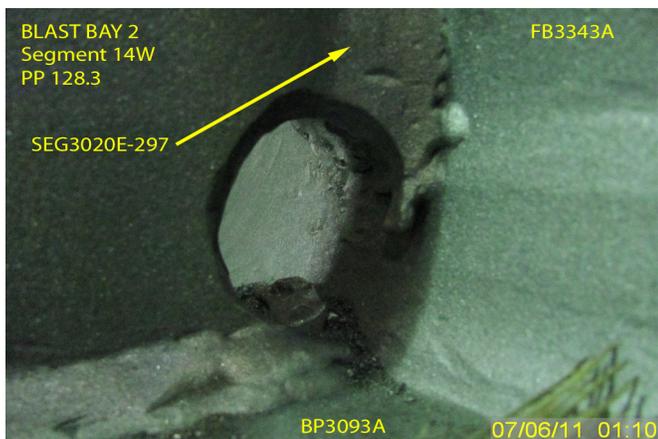
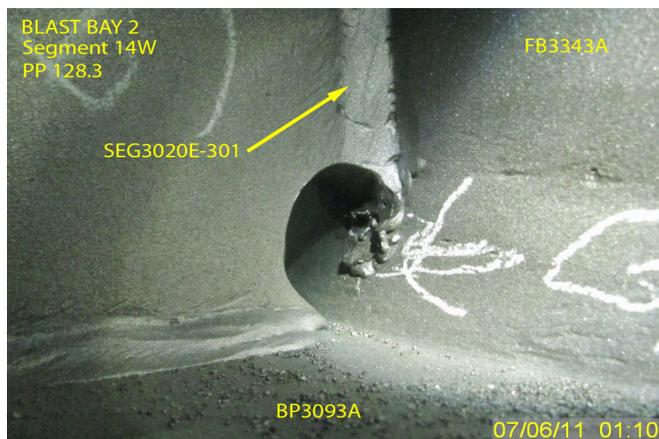
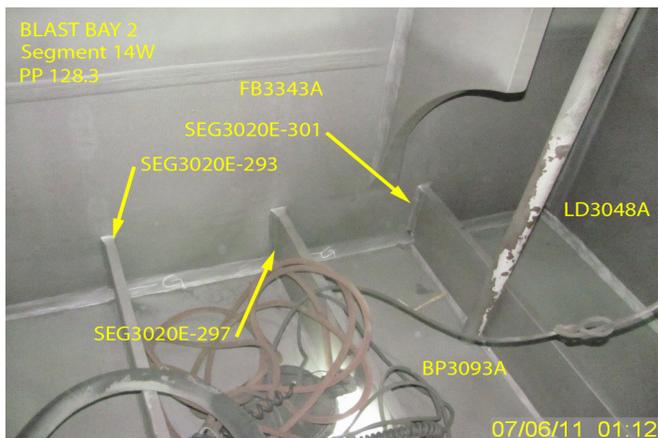
During the Quality Assurance Visual Testing (VT) of Post blast inspection; this QA inspector performed a visual inspection on internal box surfaces. The areas that were presented to this QA inspector were between PP 128.3 to PP 128.7 from W3 to W16, all areas inspected were internal from Bottom Plate to one meter above top of Bottom Plate and Side Plate. This QA inspector found multiple areas requiring additional grinding, and cleaning. The areas that only required grinding were marked for repair, and the ABF QC was notified of the locations marked. The information was transferred to the appropriate weld maps and post blast inspection report and sent to the appropriate personnel for tracking and punch list.
