DEPARTMENT OF TRANSPORTATION

Contract #: 04-0120F4Cty: SF/ALA Rte: 80 PM: 13.2/13.9File #: 69.28**WELDING INSPECTION REPORT****Resident Engineer:** Siegenthaler, Peter**Address:** 333 Burma Road**City:** Oakland, CA 94607**Report No:** WIR-025877**Date Inspected:** 25-Jul-2011**Project Name:** SAS Superstructure**OSM Arrival Time:** 1500**Prime Contractor:** American Bridge/Fluor Enterprises, a JV**OSM Departure Time:** 300**Contractor:** Zhenhua Port Machinery Company, Ltd (ZPMC), Changxing Island **Location:** ShangHai, China

WELDING INSPECTION REPORT

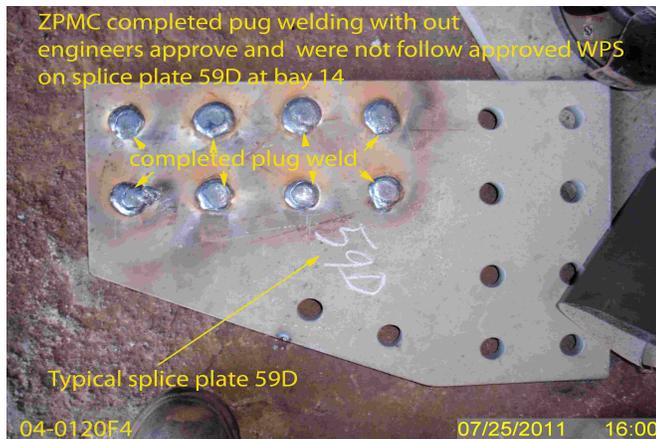
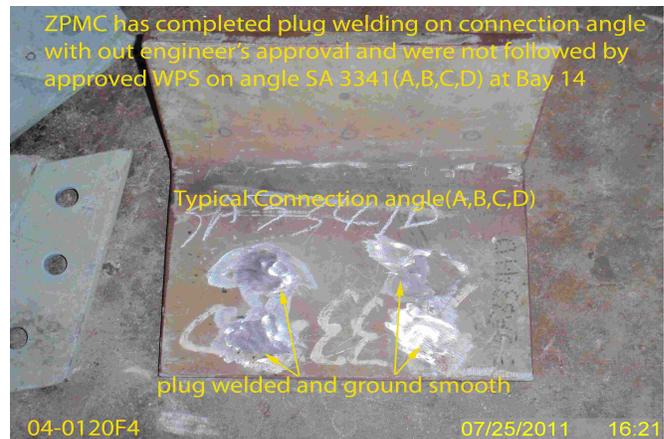
Description of Incident: During the Quality Assurance (QA) random visual inspection of splice plate and connecting angle in Bay 14, this QA Inspector discovered the following issues:

- ZPMC has completed plug weld on connection angle SA-3341A,B,C,D
- ZPMC has completed plug weld on splice plate 59D, total 8 bolt holes were completed plug weld out of 18 holes
- There are total No of 4 splice plates (59D), and 4 pieces of SA3341(A~D)
- The plug welding was not approved by the Engineer.
- The plug welding was not followed by approved procedure.
- splice plate and connection angle is located in inside BAY 14.
