DEPARTMENT OF TRANSPORTATION

Contract #: 04-0120F4Cty: SF/ALA Rte: 80 PM: 13.2/13.9File #: 1.28**WELDING INSPECTION REPORT****Resident Engineer:** Siegenthaler, Peter**Address:** 333 Burma Road**City:** Oakland, CA 94607**Report No:** WIR-025891**Date Inspected:** 10-Aug-2011**Project Name:** SAS Superstructure**OSM Arrival Time:** 700**Prime Contractor:** American Bridge/Fluor Enterprises, a JV**OSM Departure Time:** 1530**Contractor:** American Bridge/Fluor Enterprises, a JV**Location:** Job Site**CWI Name:** Fred Von Hoff**CWI Present:** Yes No**Inspected CWI report:** Yes No N/A**Rod Oven in Use:** Yes No N/A**Electrode to specification:** Yes No N/A**Weld Procedures Followed:** Yes No N/A**Qualified Welders:** Yes No N/A**Verified Joint Fit-up:** Yes No N/A**Approved Drawings:** Yes No N/A**Approved WPS:** Yes No N/A**Delayed / Cancelled:** Yes No N/A**Bridge No:** 34-0006**Component:** OBG Sections**Summary of Items Observed:**

WELDING INSPECTION REPORT

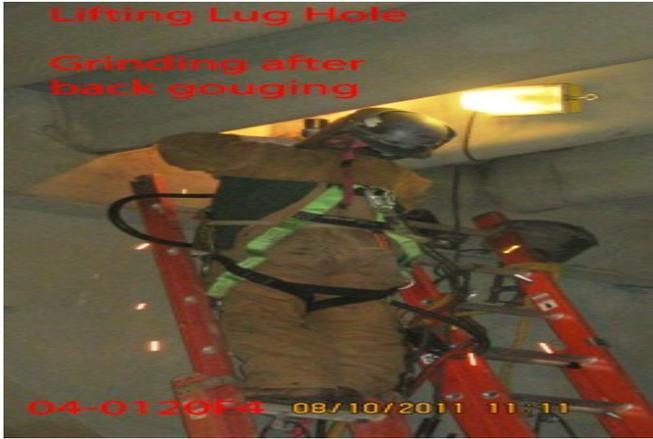
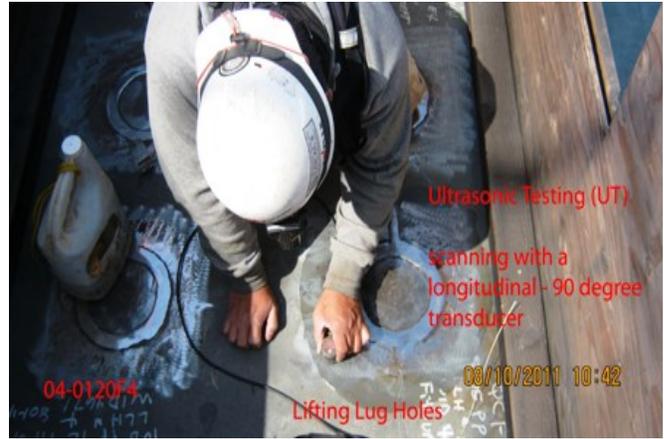
9E-PP80-E3 Lifting Lug Holes (LLH) #1 thru #4: This QA Inspector randomly observed ABF welding personnel Sal Sandoval (#2202) using the Shielded Metal Arc Welding (SMAW) process in the overhead (4G) position on holes #2 and #4 inside the OBG at this location. This QA Inspector observed QC Inspector Fred Von Hoff perform a verification of the following welding parameters; 130 amperes using a 3.2 mm diameter E7018H4R electrode. This QA Inspector performed a random verification of the base metal temperature using an electronic temperature gauge and observed the preheat and interpass temperatures were within the ranges specified on the Welding Procedure Specification (WPS). This QA Inspector randomly observed grinding being performed and that it appeared the welding at these two holes (#2 and #4) were completed. See photo below of grinding in process. This QA Inspector later observed ABF welding personnel Sal Sandoval (#2202) had switched sides and was using the carbon arc process to back gouge the #1 and #3 holes. This QA Inspector observed QC Inspector Fred Von Hoff periodically monitoring the work at this location. The welding observed this date appeared to comply with ABF-WPS-D15-1050A-CU.

Mike Jimenez (#4671) using the SMAW process in the overhead position (4G) on holes #2 and #4 inside the OBG at this location. This QA Inspector observed QC Inspector Fred Von Hoff perform a verification of the following welding parameters; 130 amperes using a 3.2 mm diameter E7018H4R electrode. This QA Inspector performed a random verification of the base metal temperature using an electronic temperature gauge and observed the preheat and interpass temperatures were within the ranges specified on the Welding Procedure Specification (WPS). This QA Inspector was informed the welding for holes #2 and #4 were completed and ready for a visual inspection by ABF welding personnel Mike Jimenez (#4671). This QA Inspector observed QC Inspector Fred Von Hoff perform a visual inspection and was informed that both welds were accepted. This QA Inspector performed a random visual verification and the work appeared to comply with the contract requirements. QC Inspector Fred Von Hoff informed ABF welding personnel Mike Jimenez (#4671) and this QA Inspector he would perform the Magnetic Particle Testing (MT) the following day, 24 hours after welding was completed in order to comply with the contract requirements. The work observed at this location appeared to comply with ABF-WPS-D15-1050A CU.
