DEPARTMENT OF TRANSPORTATION

Contract #: 04-0120F4Cty: SF/ALA Rte: 80 PM: 13.2/13.9File #: 99.28**WELDING INSPECTION REPORT****Resident Engineer:** Siegenthaler, Peter**Address:** 333 Burma Road**City:** Oakland, CA 94607**Report No:** WIR-025903**Date Inspected:** 02-Aug-2011**Project Name:** SAS Superstructure**OSM Arrival Time:** 800**Prime Contractor:** American Bridge/Fluor Enterprises, a JV**OSM Departure Time:** 1630**Contractor:** Watson Bowman Acme Corp.**Location:** Buffalo, NY**CWI Name:** Greg Ross**CWI Present:** Yes No**Inspected CWI report:** Yes No N/A**Rod Oven in Use:** Yes No N/A**Electrode to specification:** Yes No N/A**Weld Procedures Followed:** Yes No N/A**Qualified Welders:** Yes No N/A**Verified Joint Fit-up:** Yes No N/A**Approved Drawings:** Yes No N/A**Approved WPS:** Yes No N/A**Delayed / Cancelled:** Yes No N/A**Bridge No:** 34-0006**Component:** Seismic Joint Hinge A**Summary of Items Observed:**

WELDING INSPECTION REPORT

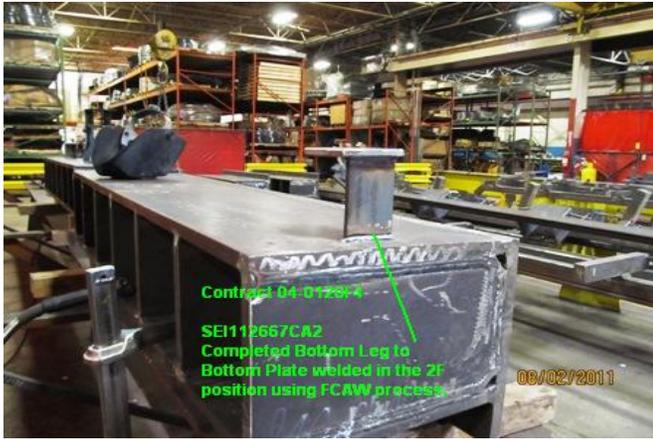
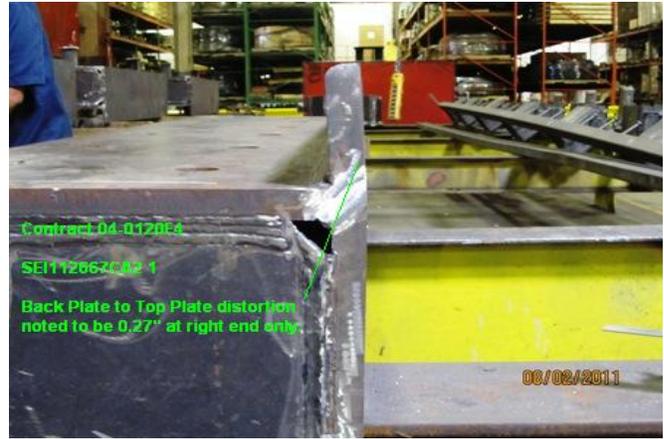
This QAI observed certified welder Jayson Gray (welder ID#J) using the FCAW process (dual shield, 100%CO₂), filler metal TM-811N1, to weld fillet welds on the SEI112667CA2 quantity of (4ea) of (24ea required) Channel Assemblies were completed at this time. Welds were performed on the Bottom Plate to Channel Leg connections.

All welding was being performed in the 2F position. QAI informed QCM, QCS and AWS CWI that Incident Report #87 will be issued for Welding without an approved 2F position, FCAW process Welding Procedure Specification (WPS) within the Welding Quality Control Plan (WQCP). WPS used was WPS #FCAW-11.

It was noted that 3/16" to 1/4" distortion exists within the Top Plate to Back Plate area on SEI112667CA2 2, SEI112667CA2 3, SEI112667CA2 4 and found to be acceptable. However on SEI112667CA2 1, it was noted to be in excess of 1/4" distortion tolerance and was measured to be 0.27". SMR Bahjat Dagher was notified of distortion issue on SEI112667CA2 1.
