DEPARTMENT OF TRANSPORTATION

Contract #: 04-0120F4Cty: SF/ALA Rte: 80 PM: 13.2/13.9File #: 99.28**WELDING INSPECTION REPORT****Resident Engineer:** Siegenthaler, Peter**Address:** 333 Burma Road**City:** Oakland, CA 94607**Report No:** WIR-025912**Date Inspected:** 27-Jul-2011**Project Name:** SAS Superstructure**OSM Arrival Time:** 700**Prime Contractor:** American Bridge/Fluor Enterprises, a JV**OSM Departure Time:** 1900**Contractor:** Zhenhua Port Machinery Company, Ltd (ZPMC), Changxing Island**Location:** Shanghai**CWI Name:****CWI Present:**

Bridge No: 34-0006**Component:** OBG**Summary of Items Observed:**

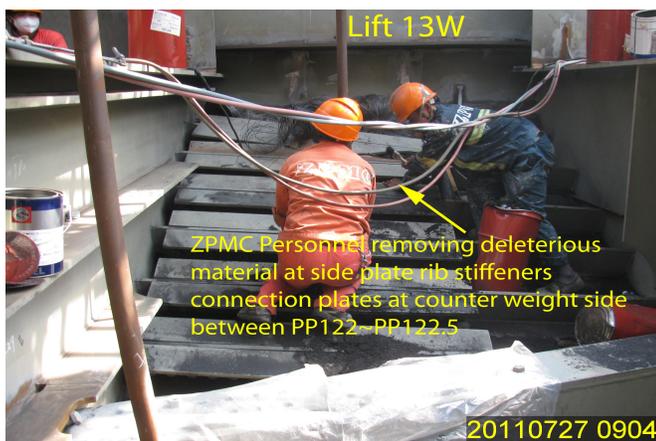
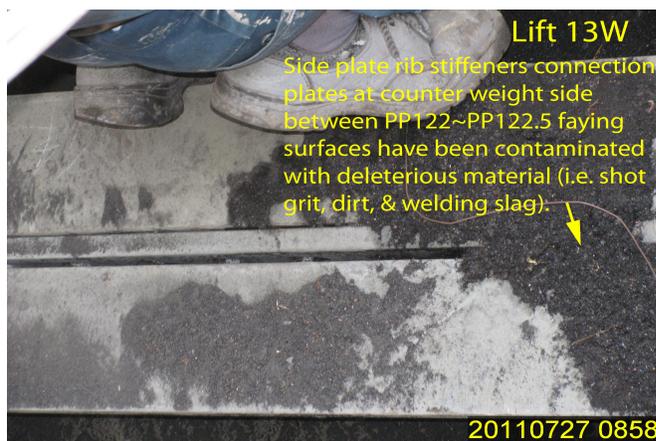
- Horizontal connection plates connecting longitudinal diaphragm to deck panels at W3 and W4 lines between PP120 and PP124.5. Tensioning is complete.
- Bottom plate and side Plate PP120 to PP124.5 stiffeners installed but not tightened at this time.
- Horizontal connection plates between Longitudinal Diaphragms and Floor Beams on W3 and W4 lines from bottom plate elevation to Deck plate elevation between PP120 and PP124. Pre-tensioning and installation in progress.
- Bottom plate and side plate rib stiffeners connection plates at counter weight side between PP120~PP120.5, PP121~PP121.5, & PP122~PP122.5 faying surfaces have been contaminated with deleterious material (i.e. shot grit, dirt, & welding slag). Note: faying surfaces must be cleaned prior to pre-tensioning and final tensioning.

Note: This QA inspector has verbally notified ZPMC QC personnel that faying surfaces have been contaminated

with deleterious material (i.e. shot grit, dirt, & welding slag), and that all faying surfaces must be cleaned prior to pre-tensioning and final tensioning.

Bolting on the above named areas is in progress and still requires final tension verification prior to final acceptance. The QA Inspector verified installation of the high strength bolts on a random basis and the results appeared to be in general compliance. No notifications have been issued for these installations.
