**DEPARTMENT OF TRANSPORTATION**

Contract #: 04-0120F4Cty: SF/ALA Rte: 80 PM: 13.2/13.9File #: 1.28**WELDING INSPECTION REPORT****Resident Engineer:** Siegenthaler, Peter**Address:** 333 Burma Road**City:** Oakland, CA 94607**Report No:** WIR-025931**Date Inspected:** 11-Aug-2011**Project Name:** SAS Superstructure**OSM Arrival Time:** 700**Prime Contractor:** American Bridge/Fluor Enterprises, a JV**OSM Departure Time:** 1530**Contractor:** American Bridge/Fluor Enterprises, a JV**Location:** Job Site

**Bridge No:** 34-0006**Component:** SAS Tower**Summary of Items Observed:**

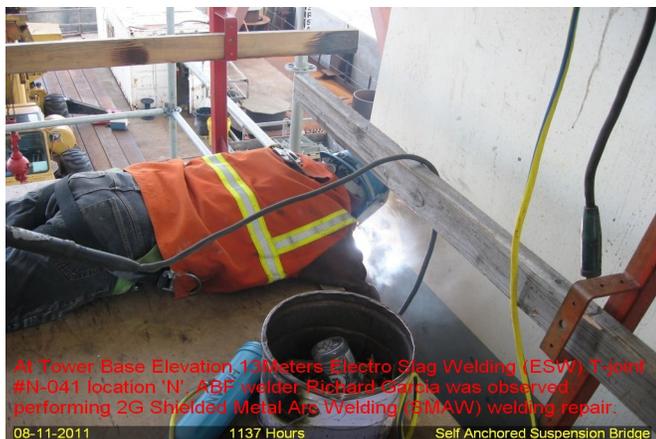
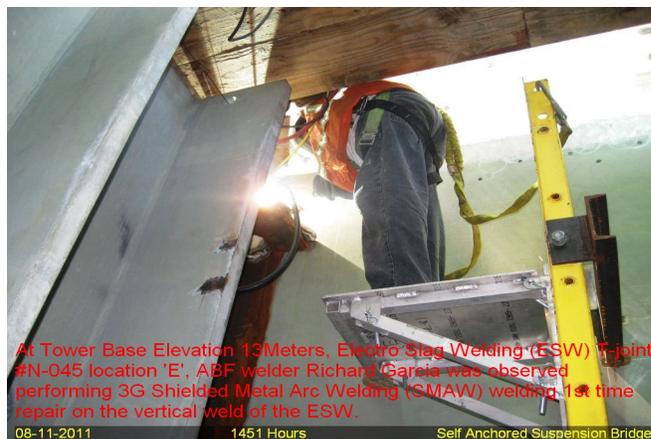
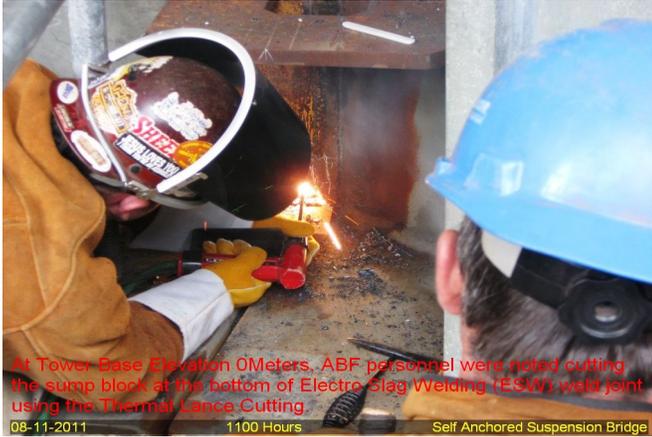
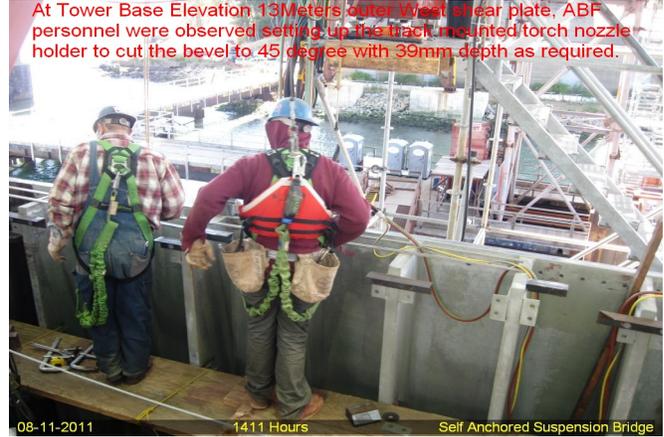
At Tower Base Elevation 13Meters, Electro Slag Welding (ESW) T-joint S-041 location 'S', QA randomly observed ABF/JV qualified welder Jeremy Dolman continuing to perform CJP groove welding repair on the top of the welded ESW due to ABF QC noted linear indications that propagated into the Tower skin plate. The top of the ESW weld joint is being repaired with approval through Repair Welding Request (RWR) # 201108-008. The welder was observed welding in the 2G (horizontal) position utilizing Shielded Metal Arc Welding (SMAW) with 1/8" diameter E7018H4R electrode implementing welding procedure ABF-WPS-D15-1000-Repairs. The weld repair was preheated to more than 300 degree Fahrenheit using propylene gas torch prior welding. During the shift, ABF QC John Pagliero was noted monitoring the welder. Measured welding parameter during welding was 110 amperes on a 1/8" diameter E7018H4R electrode. At the end of the shift, 2G SMAW repair welding was still continuing and should remain tomorrow.

At Tower Base Elevation 13Meters, Electro Slag Welding (ESW) T-joint N-045 location 'E', QA randomly ABF welder Richard Garcia continuing to perform 3G SMAW welding repair on the Ultrasonic Testing (UT) detected defect on the vertical weld of the ESW. The welder was observed welding in the 3G (vertical) position utilizing Shielded Metal Arc Welding (SMAW) with 1/8" diameter E7018H4R electrode implementing welding procedure ABF-WPS-D15-1000-Repairs. The boat shape repair excavation and the adjacent base metal was preheated to more than 300°F using propylene gas torch prior welding. During the shift, ABF QC John Pagliero was noted

monitoring the welder. Measured welding parameter during welding was 122 amperes on a 1/8" diameter E7018H4R electrode. The weld repair mentioned above is being repaired through Repair Welding Request (RWR) # 201108-010. At the end of the shift, 3G repair welding was completed including grinding/cleaning of the weld cover.

After welding the repair and it has cool down to atmospheric temperature, ABF QC John Pagliero performed a preliminary Ultrasonic Testing (UT) on the welded repair. ABF QC John Pagliero has found rejectable indication that was verified by another QC Steve Mc Connell. The UT defect was immediately excavated by ABF personnel using carbon air gouging without informing QA and Caltrans. The excavation continued until the end of the shift.

At Tower Base Elevation 13Meters, Electro Slag Welding (ESW) T-joint N-041 location 'N', QA randomly observed ABF/JV qualified welder Richard Garcia continuing to perform CJP groove welding repair on the top of the welded ESW due to ABF QC noted linear indications that propagated into the Tower skin plate. The top of the ESW weld joint is being repaired with approval through Repair Welding Request (RWR) # 201108-011. The welder was observed welding in the 2G (horizontal) position utilizing Shielded Metal Arc Welding (SMAW) with 1/8" diameter E7018H4R electrode implementing welding procedure ABF-WPS-D15-1000-Repairs. The weld repair was preheated to more than 300 degree Fahrenheit using propylene gas torch prior welding. During the shift, ABF QC John Pagliero was noted monitoring the welder. Measured welding parameter during welding was 125 amperes on a 1/8" diameter E7018H4R electrode. During the shift, the welder was also noted 3G SMAW welding the excavated weld cover of the top 6 inches due to noted overlap during QC MT. At the end of the shift, 2G SMAW repair welding was still continuing and should remain tomorrow.

At Tower Base Elevation 13Meters outer West shear plate, ABF foreman Rory Hogan and other ABF personnel were noted cutting the top bevel to 45 degree and depth of 39mm as required. The personnel were noted using oxy-propylene gas torch in cutting the bevel. The work was still in progress at the end of the shift.

At Tower Base Elevation 0Meters, ABF personnel were noted cutting the shear plate sump blocks that were used during the ESW. The personnel were using Thermal Lance Cutting with 1/4" diameter iron rod and were able to complete cutting at the following ESW weld locations 'P', 'Q', 'N', 'W', 'R' and 'S'. The cut was still rough and still need to be ground smooth.
