Contract #: 04-0120F4Cty: SF/ALA Rte: 80 PM: 13.2/13.9File #: 69.28**WELDING INSPECTION REPORT****Resident Engineer:** Siegenthaler, Peter**Address:** 333 Burma Road**City:** Oakland, CA 94607**Report No:** WIR-026021**Date Inspected:** 06-Aug-2011**Project Name:** SAS Superstructure**OSM Arrival Time:** 700**Prime Contractor:** American Bridge/Fluor Enterprises, a JV**OSM Departure Time:** 1900**Contractor:** Zhenhua Port Machinery Company, Ltd (ZPMC), Changxing Island **Location:** Shanghai, China

Orthotropic Box Girder (OBG) at Trial Assembly Areas

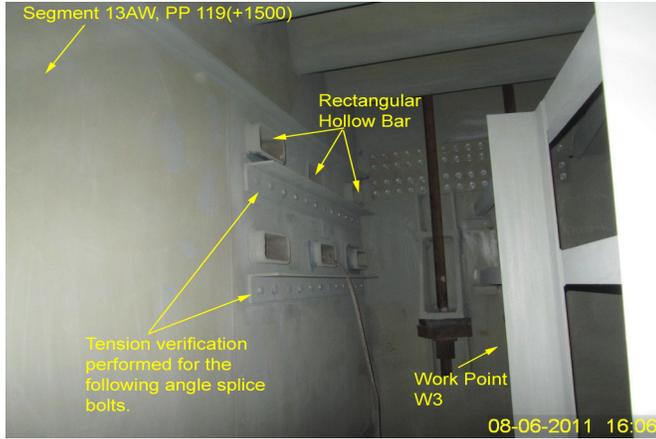
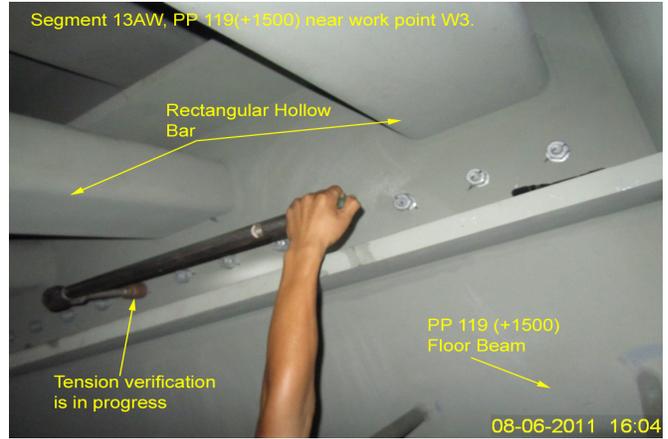
This QA Inspector witnessed final bolt tension verification on bolts connecting Angle plate to full height Longitudinal Diaphragm below the manhole at work point W4 (Cross Beam side) and at work point W3 (Counter Weight side) between Panel Points (PP) 122.5 to PP 123 for Segment 13 CW. Inspected the bolt tensioning on a random basis and found the tension to be in general compliance. Inspection was performed against the Notification No. 00670 Dated May 02, 2011.

This QA Inspector witnessed final bolt tension verification on bolts connecting Angle plate to Floor Beam below the Rectangular Hollow Bar at work point W4 (Cross Beam side) and at work point W3 (Counter Weight side) at Panel Points (PP) 119(+1500) and PP 119(-1500) for Segment 13 AW. Inspected the bolt tensioning on a random basis and found the tension to be in general compliance. Inspection was performed against the Notification No. 00746 Dated August 7, 2011.
