Contract #: 04-0120F4Cty: SF/ALA Rte: 80 PM: 13.2/13.9File #: 69.28**WELDING INSPECTION REPORT****Resident Engineer:** Siegenthaler, Peter**Address:** 333 Burma Road**City:** Oakland, CA 94607**Report No:** WIR-026029**Date Inspected:** 16-Jul-2011**Project Name:** SAS Superstructure**OSM Arrival Time:** 700**Prime Contractor:** American Bridge/Fluor Enterprises, a JV**OSM Departure Time:** 1900**Contractor:** Zhenhua Port Machinery Company, Ltd (ZPMC), Changxing Island **Location:** Shanghai, China

Orthotropic Box Girder (OBG) at Trial Assembly Areas

Segment 13AW to Segment 13BW (Deck Panel Skin Flatness)

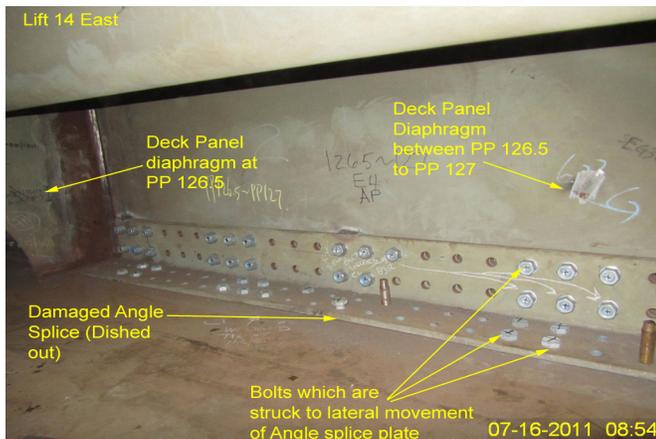
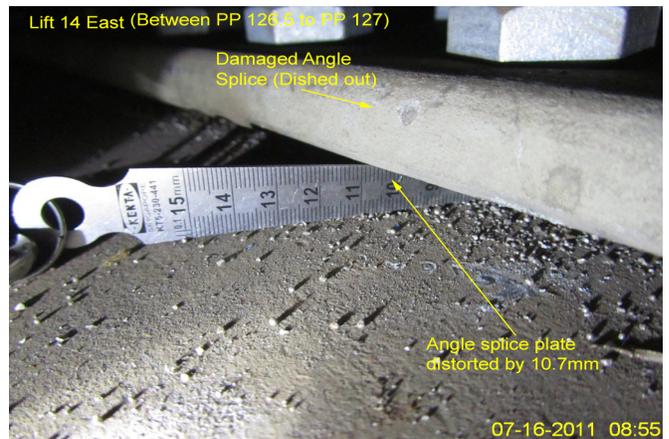
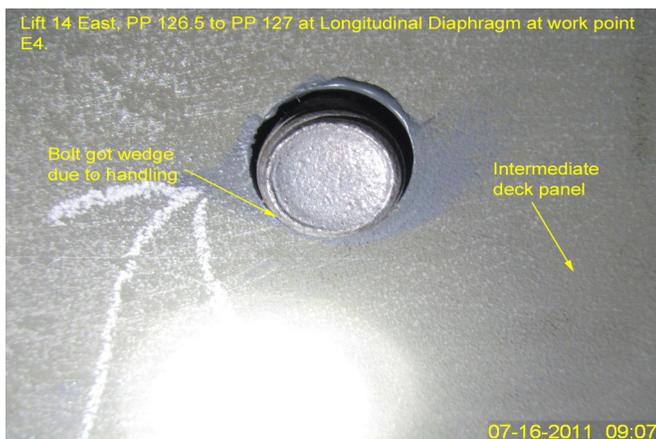
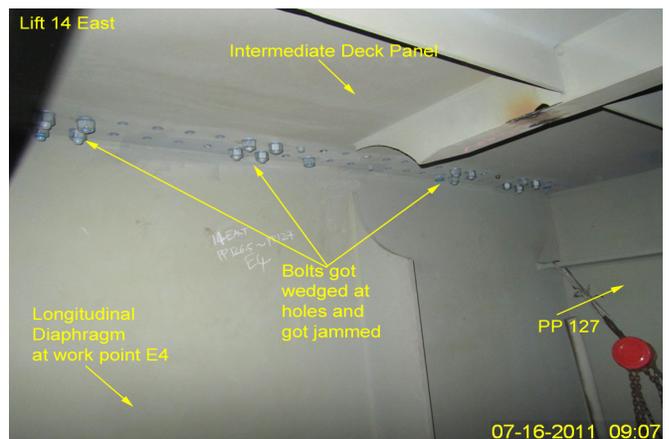
This QA Inspector performed bolt assembly inspection installed by ZPMC personals, bolts are connecting the splice plate of Anchoring plate to full Height Longitudinal Diaphragm and the inspection was performed to evaluate the bolt damage that had incurred during the lifting of the OBG Structure to place it on the ZPMC Ship # 19.

During the course of lifting the Lift 14 East on July 15, 2011, the ZPMC Derrick Barge 2200 Ton pulley got struck, thus inspection was performed for accessing whether any damage had incurred to the fasteners assemblies.

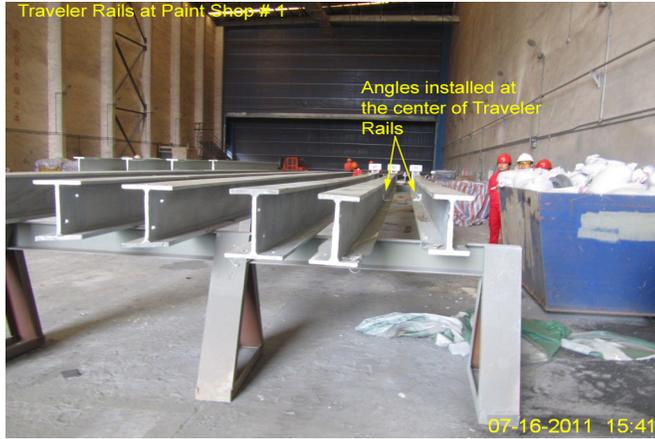
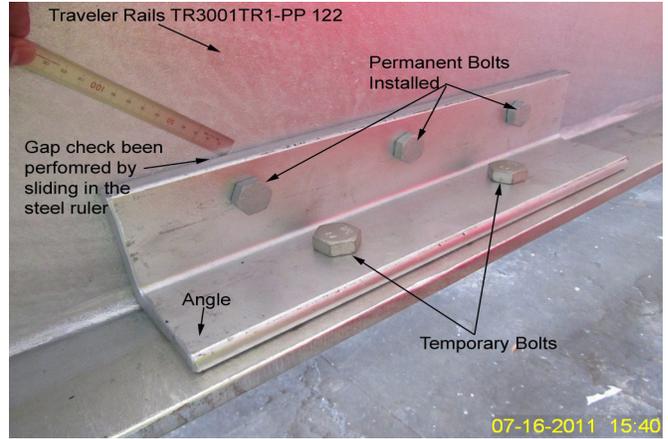
This QA Inspector performed the gap inspection between the angle pieces installed at center of the Traveler Rail at Paint Shop # 1 and observed the gap appeared to be in general compliance. The Inspection was performed against

Notification No. 00590.

The following Traveler Rails were inspected.

3001TR2- PP122

3007TR1- PP120/121/122

3007TR2- PP122

3001TR1- PP122
