DEPARTMENT OF TRANSPORTATION

Contract #: 04-0120F4Cty: SF/ALA Rte: 80 PM: 13.2/13.9File #: 69.28**WELDING INSPECTION REPORT****Resident Engineer:** Siegenthaler, Peter**Address:** 333 Burma Road**City:** Oakland, CA 94607**Report No:** WIR-026035**Date Inspected:** 23-Jul-2011**Project Name:** SAS Superstructure**OSM Arrival Time:** 700**Prime Contractor:** American Bridge/Fluor Enterprises, a JV**OSM Departure Time:** 1900**Contractor:** Zhenhua Port Machinery Company, Ltd (ZPMC), Changxing Island **Location:** Shanghai, China

Orthotropic Box Girder (OBG) at Trial Assembly Areas

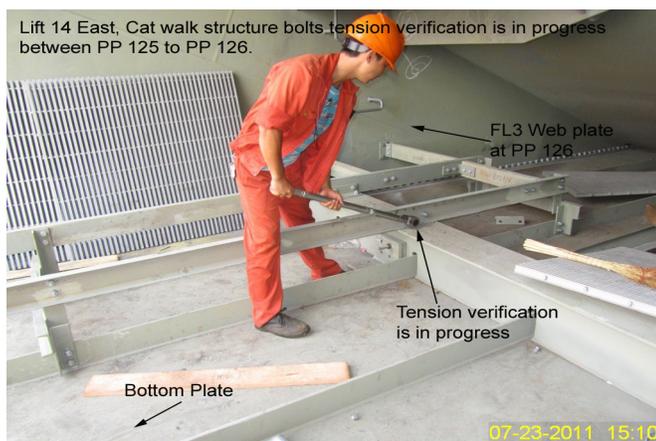
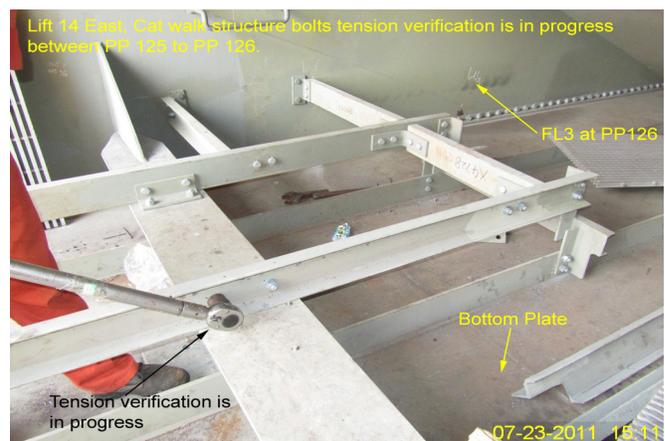
This QA Inspector witnessed the final bolt tension verification on bolts connecting the Bottom Plate to FL3 Flange and Bottom Panel to Bottom Plate at Panel Points (PP) 118 (west side), 118.35 (east and west side), 119 (east and west side) and 119.65 (east and west side) for Segment 13AW. The QA Inspector verified the bolt tension on a random basis and the results appeared to be in general compliance. The Inspection was performed against Notification No. 00704 dated July 23, 2011.

This Quality Assurance (QA) Inspector witnessed final bolt tension verification for Catwalk structure installed at FL3 Bottom Plate between Panel Point (PP) 125 and PP 126. Inspected 10% on a random basis and found the tension to be in general compliance. Inspection was performed against the Notification No. 00706 dated July 23, 2011.

This Quality Assurance (QA) Inspector observed Lift 13 East (comprising Segments 13AE, 13BE and 13CE) is lifted from the OBG Trail Assembly to place it on the ZPMC ship # 19, which is berth at jetty # 5.
