**DEPARTMENT OF TRANSPORTATION**

Quality Assurance and Source Inspection

Contract #: 04-0120F4Cty: SF/ALA Rte: 80 PM: 13.2/13.9File #: 69.28**WELDING INSPECTION REPORT****Resident Engineer:** Siegenthaler, Peter**Address:** 333 Burma Road**City:** Oakland, CA 94607**Report No:** WIR-026041**Date Inspected:** 04-Jul-2011**Project Name:** SAS Superstructure**OSM Arrival Time:** 700**Prime Contractor:** American Bridge/Fluor Enterprises, a JV**OSM Departure Time:** 1900**Contractor:** Zhenhua Port Machinery Company, Ltd (ZPMC), Changxing Island **Location:** Shanghai, China

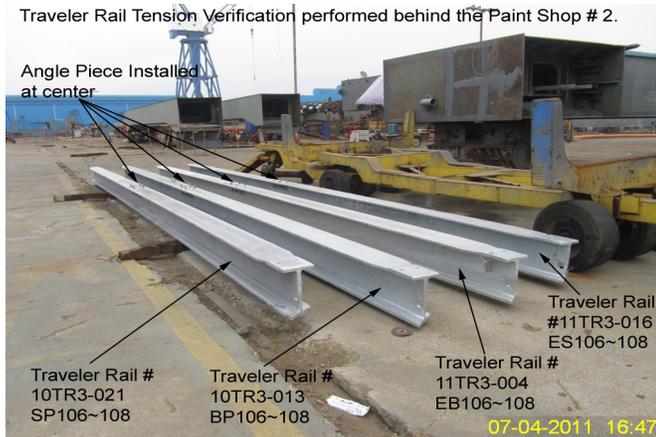
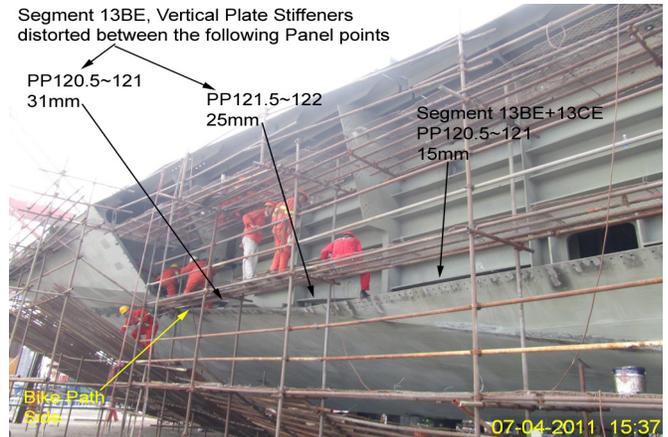
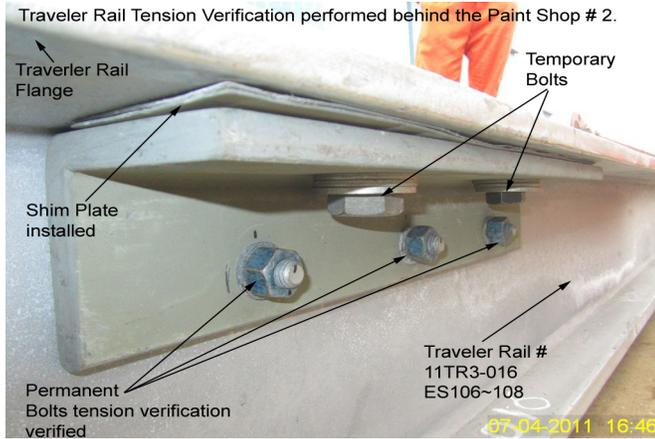
Inspection Results: The QA Inspector observed gap between the Angle Piece installed at center of the traveler rail Flange asked the ZPMC QC to fix it. Thus ZPMC QC cancelled the Inspection and informed the QA that he will re-offer after rectification.

Inspection Results: The QA Inspector observed gap between the Angle Piece installed at center of the traveler rail Flange is mitigated by adding shim plates and torque by using a temporary bolts, the gap was checked and observed within the tolerance. Thus the above mentioned traveler Rails were accepted.

Observed the first Stiffener from the bottom distortion as 31mm, between PP 120.5 to PP 121.

Observed the first Stiffener from the bottom distortion as 25mm, between PP 121.5 to PP 122.

Observed the first Stiffener from the bottom distortion as 15mm, between PP 122 to PP 122.5.
