DEPARTMENT OF TRANSPORTATION

Office of Structural Materials

Contract #: 04-0120F4Cty: SF/ALA Rte: 80 PM: 13.2/13.9File #: 1.28**WELDING INSPECTION REPORT****Resident Engineer:** Siegenthaler, Peter**Address:** 333 Burma Road**City:** Oakland, CA 94607**Report No:** WIR-026049**Date Inspected:** 05-Aug-2011**Project Name:** SAS Superstructure**OSM Arrival Time:** 700**Prime Contractor:** American Bridge/Fluor Enterprises, a JV**OSM Departure Time:** 1530**Contractor:** American Bridge/Fluor Enterprises, a JV**Location:** Job Site**CWI Name:** See Below**CWI Present:** Yes No**Inspected CWI report:** Yes No N/A**Rod Oven in Use:** Yes No N/A**Electrode to specification:** Yes No N/A**Weld Procedures Followed:** Yes No N/A**Qualified Welders:** Yes No N/A**Verified Joint Fit-up:** Yes No N/A**Approved Drawings:** Yes No N/A**Approved WPS:** Yes No N/A**Delayed / Cancelled:** Yes No N/A**Bridge No:** 34-0006**Component:** Orthotropic Box Girder & Tower**Summary of Items Observed:**

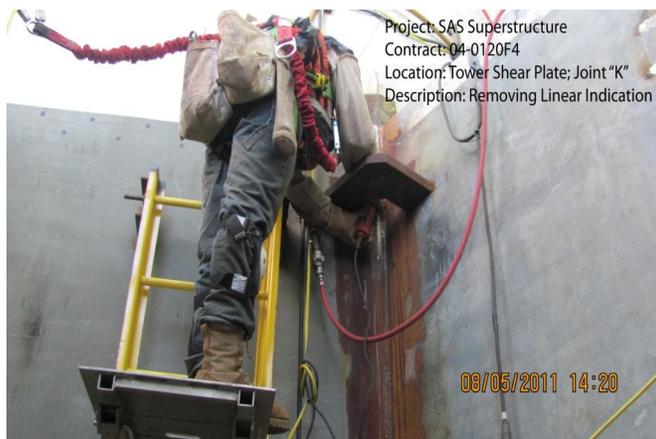
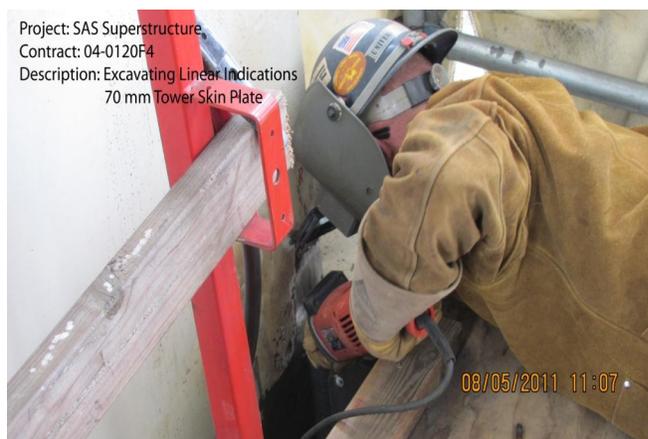
The digital photographs below illustrate some of the work observed during this scheduled work date.
