DEPARTMENT OF TRANSPORTATION

Quality Assurance and Source Inspection

Contract #: 04-0120F4Cty: SF/ALA Rte: 80 PM: 13.2/13.9File #: 1.28**WELDING INSPECTION REPORT****Resident Engineer:** Siegenthaler, Peter**Address:** 333 Burma Road**City:** Oakland, CA 94607**Report No:** WIR-026052**Date Inspected:** 06-Aug-2011**Project Name:** SAS Superstructure**OSM Arrival Time:** 700**Prime Contractor:** American Bridge/Fluor Enterprises, a JV**OSM Departure Time:** 1400**Contractor:** American Bridge/Fluor Enterprises, a JV**Location:** Job Site**CWI Name:** See Below**CWI Present:** Yes No**Inspected CWI report:** Yes No N/A**Rod Oven in Use:** Yes No N/A**Electrode to specification:** Yes No N/A**Weld Procedures Followed:** Yes No N/A**Qualified Welders:** Yes No N/A**Verified Joint Fit-up:** Yes No N/A**Approved Drawings:** Yes No N/A**Approved WPS:** Yes No N/A**Delayed / Cancelled:** Yes No N/A**Bridge No:** 34-0006**Component:** Orthotropic Box Girder & Tower**Summary of Items Observed:**

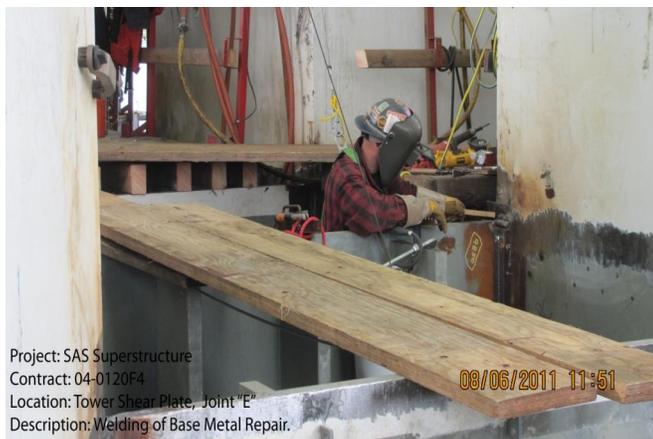
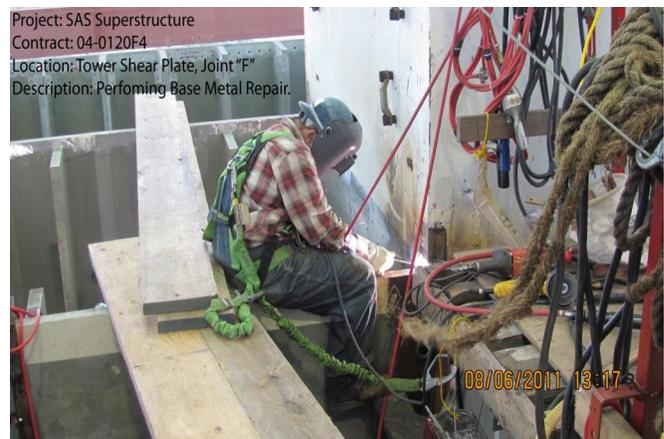
Later in the shift, the QAI observed the base metal repair welding located at joint "S" above the shear plate ESW identified as WN: S-042. The welding was performed by Fred Kaddu ID-2188 utilizing the WPS identified as ABF-WPS-D15-1000-Repair, Rev.2. The welding parameters were measured by the QC inspector John Pagliero and were noted as 143 amps.

The QC inspector utilized the repair WPS as a reference to monitor the welding and the related work pertaining the base metal repairs. The welding was performed in the horizontal (2G) position with the work positioned in an approximate vertical plane with the excavations approximately horizontal.

The digital photographs below illustrate some of the work observed during this scheduled work date.
