**DEPARTMENT OF TRANSPORTATION**

Contract #: 04-0120F4Cty: SF/ALA Rte: 80 PM: 13.2/13.9File #: 1.28**WELDING INSPECTION REPORT****Resident Engineer:** Siegenthaler, Peter**Address:** 333 Burma Road**City:** Oakland, CA 94607**Report No:** WIR-026056**Date Inspected:** 15-Aug-2011**Project Name:** SAS Superstructure**OSM Arrival Time:** 700**Prime Contractor:** American Bridge/Fluor Enterprises, a JV**OSM Departure Time:** 1730**Contractor:** American Bridge/Fluor Enterprises, a JV**Location:** Job Site

**Bridge No:** 34-0006**Component:** SAS Tower**Summary of Items Observed:**

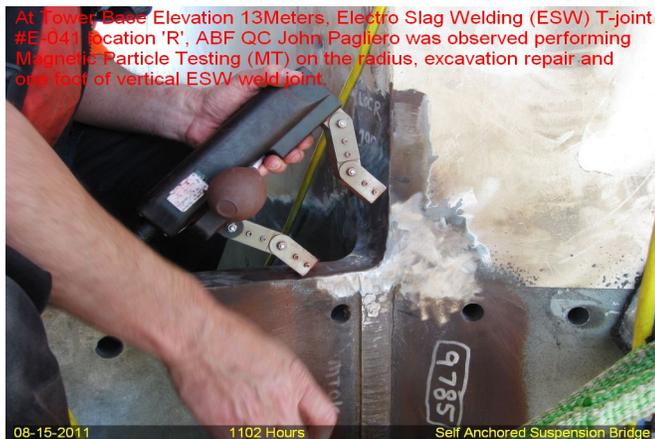
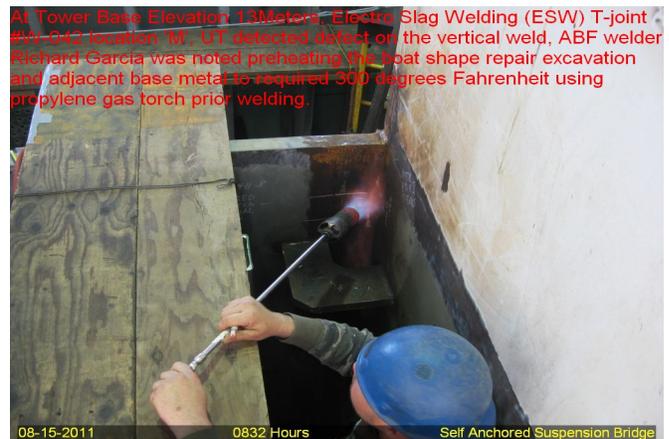
At Tower Base Elevation 13Meters, Electro Slag Welding (ESW) T-joint W-042 location 'M', QA randomly observed ABF/JV qualified welder Richard Garcia perform CJP groove welding repair on the top 165mm to 315mm of the vertical welded ESW due to detected defect from Ultrasonic Testing (UT). The repair was previously excavated using carbon air arc gouging then ground smooth using a die grinder. After grinding to a depth of 40mm, ABF QC Pat Swain performed Magnetic Particle Testing (MT) on the excavated defect removal. The result was not good enough and that the linear indication was still evident. Upon the advice of ABF QC Pat Swain, ABF should get approval from the Engineer if ABF wants to excavate further and remove the indication. At this point the welder stopped grinding and decided to wait for further instruction from the foreman.

Today upon the instruction from ABF Superintendent, ABF decided to weld the repair excavation on one side and then after the completion from one side to go to the opposite side of the repair excavation and excavate the remaining linear indication. The boat shape repair excavation was measured 150mm long x 35mm wide x 40mm deep.

The welder was observed welding in the 3G (vertical) position utilizing Shielded Metal Arc Welding (SMAW) with 1/8" diameter E7018H4R electrode implementing welding procedure ABF-WPS-D15-1000-Repairs. The weld repair was preheated to more than 300 degree Fahrenheit using propylene gas torch prior welding. During the

shift, ABF QC John Pagliero was noted monitoring the welder. Measured welding parameter during welding was 150 amperes on a 1/8" diameter E7018H4R electrode. At the end of the shift, welding repair on one side of the ESW excavation was completed. ABF intends to perform the excavation on the opposite side of the repair to remove the remaining linear indication tomorrow.
