DEPARTMENT OF TRANSPORTATION

Office of Structural Materials

Contract #: 04-0120F4Cty: SF/ALA Rte: 80 PM: 13.2/13.9File #: 1.28**WELDING INSPECTION REPORT****Resident Engineer:** Siegenthaler, Peter**Address:** 333 Burma Road**City:** Oakland, CA 94607**Report No:** WIR-026058**Date Inspected:** 10-Aug-2011**Project Name:** SAS Superstructure**OSM Arrival Time:** 700**Prime Contractor:** American Bridge/Fluor Enterprises, a JV**OSM Departure Time:** 1730**Contractor:** American Bridge/Fluor Enterprises, a JV**Location:** Job Site**CWI Name:** See Below**CWI Present:** Yes No**Inspected CWI report:** Yes No N/A**Rod Oven in Use:** Yes No N/A**Electrode to specification:** Yes No N/A**Weld Procedures Followed:** Yes No N/A**Qualified Welders:** Yes No N/A**Verified Joint Fit-up:** Yes No N/A**Approved Drawings:** Yes No N/A**Approved WPS:** Yes No N/A**Delayed / Cancelled:** Yes No N/A**Bridge No:** 34-0006**Component:** Orthotropic Box Girder & Tower**Summary of Items Observed:**

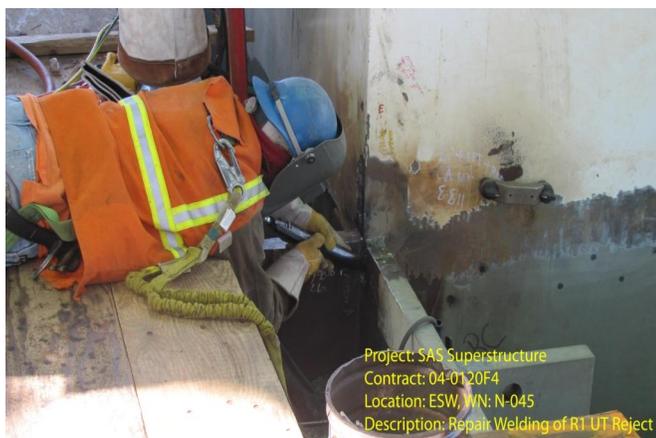
The digital photograph below illustrate some of the work observed during this scheduled work date.
