DEPARTMENT OF TRANSPORTATION

Quality Assurance and Source Inspection

Contract #: 04-0120F4Cty: SF/ALA Rte: 80 PM: 13.2/13.9File #: 1.28**WELDING INSPECTION REPORT****Resident Engineer:** Siegenthaler, Peter**Address:** 333 Burma Road**City:** Oakland, CA 94607**Report No:** WIR-026059**Date Inspected:** 11-Aug-2011**Project Name:** SAS Superstructure**OSM Arrival Time:** 700**Prime Contractor:** American Bridge/Fluor Enterprises, a JV**OSM Departure Time:** 1730**Contractor:** American Bridge/Fluor Enterprises, a JV**Location:** Job Site**CWI Name:** See Below**CWI Present:** Yes No**Inspected CWI report:** Yes No N/A**Rod Oven in Use:** Yes No N/A**Electrode to specification:** Yes No N/A**Weld Procedures Followed:** Yes No N/A**Qualified Welders:** Yes No N/A**Verified Joint Fit-up:** Yes No N/A**Approved Drawings:** Yes No N/A**Approved WPS:** Yes No N/A**Delayed / Cancelled:** Yes No N/A**Bridge No:** 34-0006**Component:** Orthotropic Box Girder & Tower**Summary of Items Observed:**

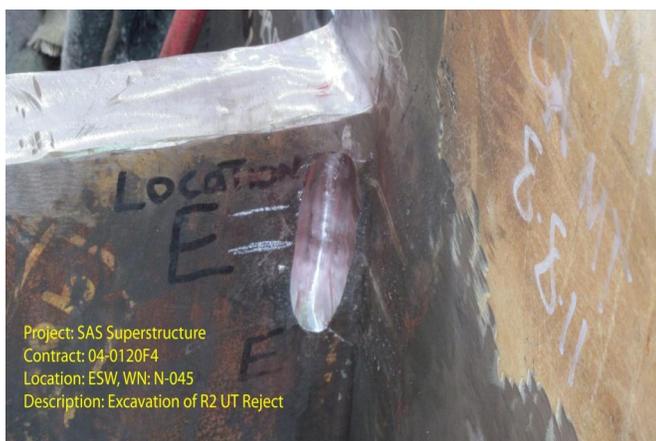
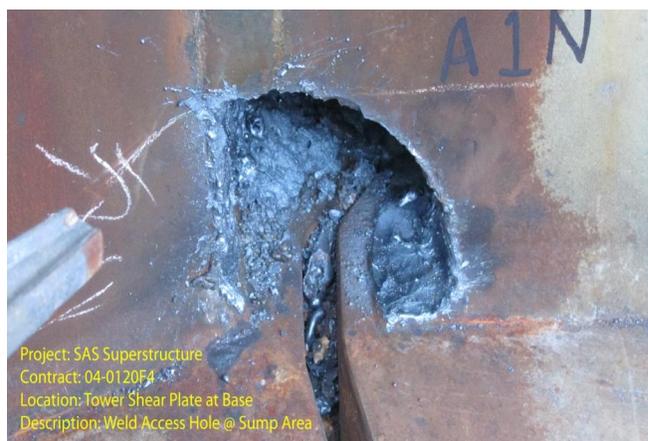
The digital photographs below illustrate some of the work observed during this scheduled work date.
