DEPARTMENT OF TRANSPORTATION

Quality Assurance and Source Inspection

Bridge No: 34-0006**Component:** OBG**Summary of Items Observed:**

WELDING INSPECTION REPORT

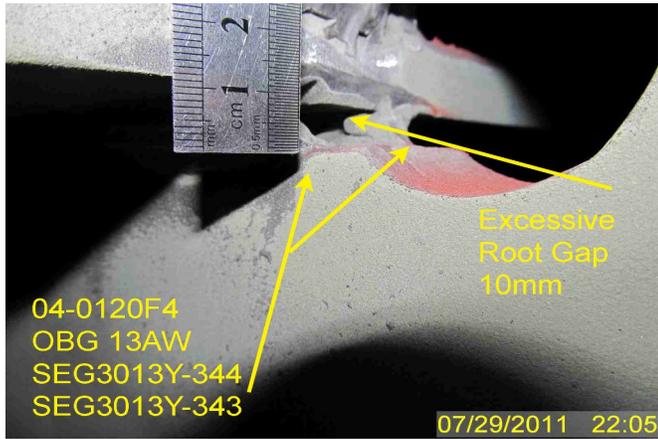
This QA inspector observed excessive weld (root) gap at 13AW interior longitudinal diaphragm connection plate to floor beam flange at PP119 +1500 weld SEG3013Y-343 and 344. This QA inspector generated a Quality

Assurance-Incident Report for excessive weld gap. See Quality Assurance-Incident Report, dated 07-29-11 for additional information.

The following digital picture illustrates excessive weld gap.
