DEPARTMENT OF TRANSPORTATION

Contract #: 04-0120F4Cty: SF/ALA Rte: 80 PM: 13.2/13.9File #: 69.28**WELDING INSPECTION REPORT****Resident Engineer:** Siegenthaler, Peter**Address:** 333 Burma Road**City:** Oakland, CA 94607**Report No:** WIR-026096**Date Inspected:** 07-Jul-2011**Project Name:** SAS Superstructure**OSM Arrival Time:** 1900**Prime Contractor:** American Bridge/Fluor Enterprises, a JV**OSM Departure Time:** 700**Contractor:** Zhenhua Port Machinery Company, Ltd (ZPMC), Changxing Island **Location:** Shanghai, China**CWI Name:** See below**CWI Present:** Yes No**Inspected CWI report:** Yes No N/A**Rod Oven in Use:** Yes No N/A**Electrode to specification:** Yes No N/A**Weld Procedures Followed:** Yes No N/A**Qualified Welders:** Yes No N/A**Verified Joint Fit-up:** Yes No N/A**Approved Drawings:** Yes No N/A**Approved WPS:** Yes No N/A**Delayed / Cancelled:** Yes No N/A**Bridge No:** 34-0006**Component:** OBG**Summary of Items Observed:**

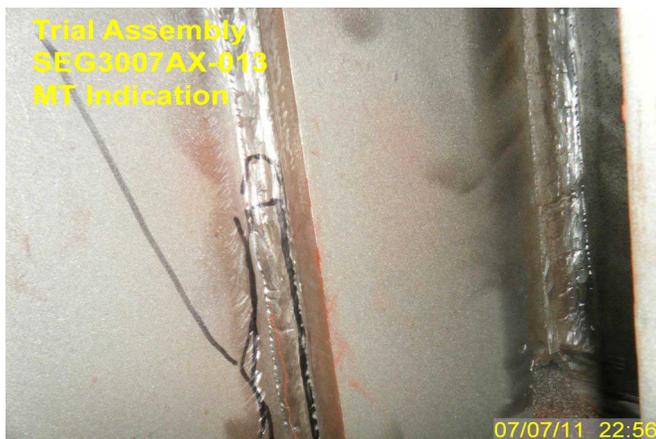
During random in-process visual inspection of welds located in OBG13E, this Quality Assurance Inspector (QA) observed a cracked weld, found by ZPMC Quality Assurance (QC) Inspectors, using Magnetic Particle Testing (MT). The area is located on SEG3007AX and identified as weld number 013. The weld was reported by ZPMC as reject and scheduled for repair. (See Photos below).
