**DEPARTMENT OF TRANSPORTATION**

Contract #: 04-0120F4Cty: SF/ALA Rte: 80 PM: 13.2/13.9File #: 1.28**WELDING INSPECTION REPORT****Resident Engineer:** Siegenthaler, Peter**Address:** 333 Burma Road**City:** Oakland, CA 94607**Report No:** WIR-026117**Date Inspected:** 17-Aug-2011**Project Name:** SAS Superstructure**OSM Arrival Time:** 700**Prime Contractor:** American Bridge/Fluor Enterprises, a JV**OSM Departure Time:** 1730**Contractor:** American Bridge/Fluor Enterprises, a JV**Location:** Job Site**CWI Name:** See Below**CWI Present:** Yes No**Inspected CWI report:** Yes No N/A**Rod Oven in Use:** Yes No N/A**Electrode to specification:** Yes No N/A**Weld Procedures Followed:** Yes No N/A**Qualified Welders:** Yes No N/A**Verified Joint Fit-up:** Yes No N/A**Approved Drawings:** Yes No N/A**Approved WPS:** Yes No N/A**Delayed / Cancelled:** Yes No N/A**Bridge No:** 34-0006**Component:** SAS Tower & OBG**Summary of Items Observed:**

## WELDING INSPECTION REPORT

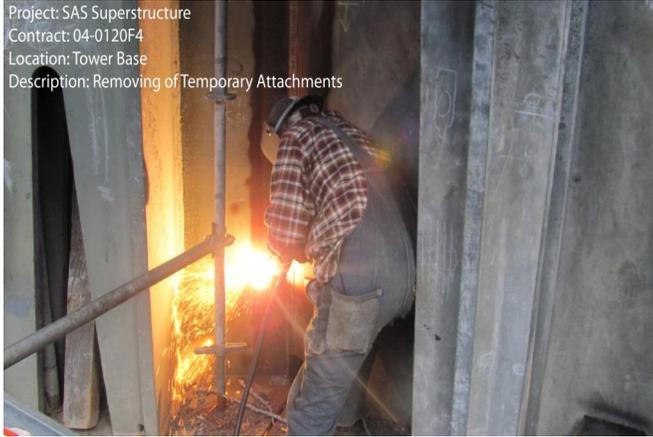
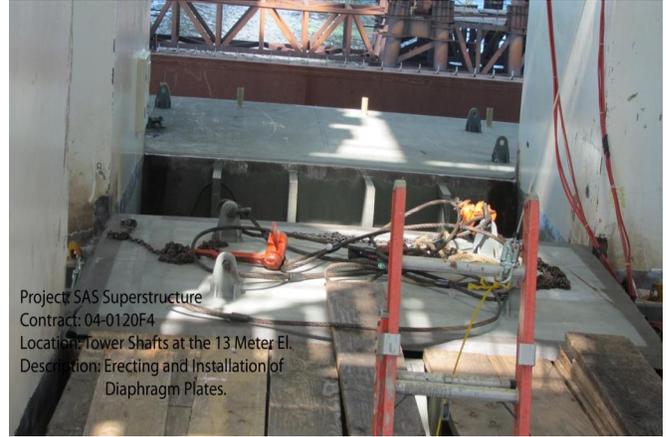
The digital photograph on page 3 of this report illustrates some of the work observed during this scheduled work date.
