Contract #: 04-0120F4Cty: SF/ALA Rte: 80 PM: 13.2/13.9File #: 1.28**WELDING INSPECTION REPORT****Resident Engineer:** Siegenthaler, Peter**Address:** 333 Burma Road**City:** Oakland, CA 94607**Report No:** WIR-026121**Date Inspected:** 18-Aug-2011**Project Name:** SAS Superstructure**OSM Arrival Time:** 700**Prime Contractor:** American Bridge/Fluor Enterprises, a JV**OSM Departure Time:** 1730**Contractor:** American Bridge/Fluor Enterprises, a JV**Location:** Job Site**CWI Name:** See Below**CWI Present:** Yes No**Inspected CWI report:** Yes No N/A**Rod Oven in Use:** Yes No N/A**Electrode to specification:** Yes No N/A**Weld Procedures Followed:** Yes No N/A**Qualified Welders:** Yes No N/A**Verified Joint Fit-up:** Yes No N/A**Approved Drawings:** Yes No N/A**Approved WPS:** Yes No N/A**Delayed / Cancelled:** Yes No N/A**Bridge No:** 34-0006**Component:** SAS Tower & OBG**Summary of Items Observed:**

A). Tower Shear Plates

B). OBG E11/E12

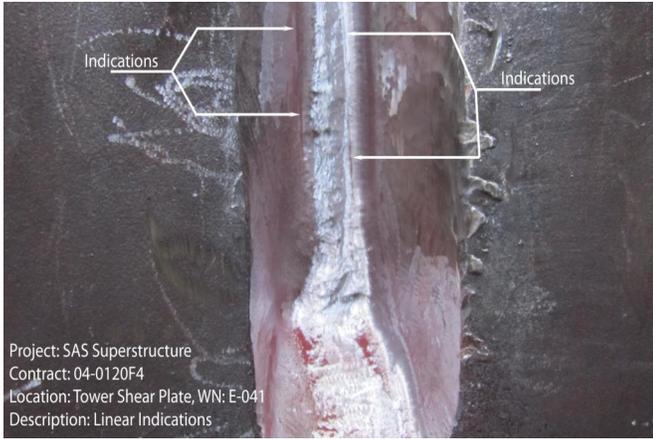
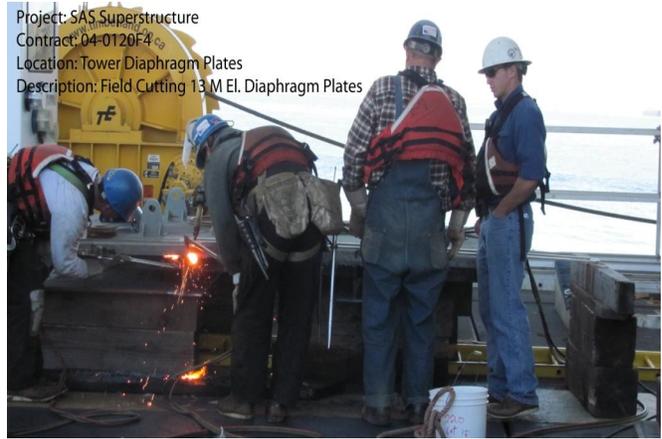
The QAI observed the welder Richard Garcia repairing the visual inspection reject of the ESW identified as WN: E-041 located at the joint designated as "R". The welder utilized the Air Carbon Arc (ACA) method to perform the excavation of this area. The QAI observed the QC inspector, Fred Von Hoff, perform a visual inspection, with the assistance of the Magnetic Particle Testing (MPT) utilizing the AC Yoke method, at random intervals during the cutting. Later in the shift the QC inspector informed this QAI that the linear indications were still visible both testing methods at a depth of 40 millimeters. At this time the welder and the QC inspector informed the shift foreman Rory Hogan and a decision was made to weld the excavation and continue the repair process from the opposite side. At the end of the shift the welder had completed the grinding the surface of the excavated area. No welding was performed on this date in regards to this issue. The dimensions of the excavation are as follows; Y=1465 mm, L=220 mm, d=40 mm and the width=60 mm.

The QAI also observed the continued repair welding of the shear plate ESW identified as WN: N-041, located at the joint designated as "N". The welding was performed by Jeremy Dolman ID-5042 utilizing the SMAW as per

The QAI observed the continued CJP welding of the side plate field splice identified as 11E-12E-E utilizing the semi-automatic FCAW-G welding process as per the WPS ABF-WPS-D15-3042B-1 Rev. 0. The welding was performed by the welding operator James Zhen ID-6001 and the inspection was performed by the QC inspector William Sherwood utilizing the Welding Procedure Specification (WPS) as a reference during the monitoring of the welding and the verifying of the welding parameters. The welding was performed in the overhead (4G) position with the work placed in a fixed position at an approximate 22 degree incline. The welding was not completed during this shift and appeared to comply with the contract documents.
