DEPARTMENT OF TRANSPORTATION

Contract #: 04-0120F4Cty: SF/ALA Rte: 80 PM: 13.2/13.9File #: 1.28**WELDING INSPECTION REPORT****Resident Engineer:** Siegenthaler, Peter**Address:** 333 Burma Road**City:** Oakland, CA 94607**Report No:** WIR-026122**Date Inspected:** 19-Aug-2011**Project Name:** SAS Superstructure**OSM Arrival Time:** 700**Prime Contractor:** American Bridge/Fluor Enterprises, a JV**OSM Departure Time:** 1530**Contractor:** American Bridge/Fluor Enterprises, a JV**Location:** Job Site**CWI Name:** See Below**CWI Present:** Yes No**Inspected CWI report:** Yes No N/A**Rod Oven in Use:** Yes No N/A**Electrode to specification:** Yes No N/A**Weld Procedures Followed:** Yes No N/A**Qualified Welders:** Yes No N/A**Verified Joint Fit-up:** Yes No N/A**Approved Drawings:** Yes No N/A**Approved WPS:** Yes No N/A**Delayed / Cancelled:** Yes No N/A**Bridge No:** 34-0006**Component:** SAS Tower & OBG**Summary of Items Observed:**

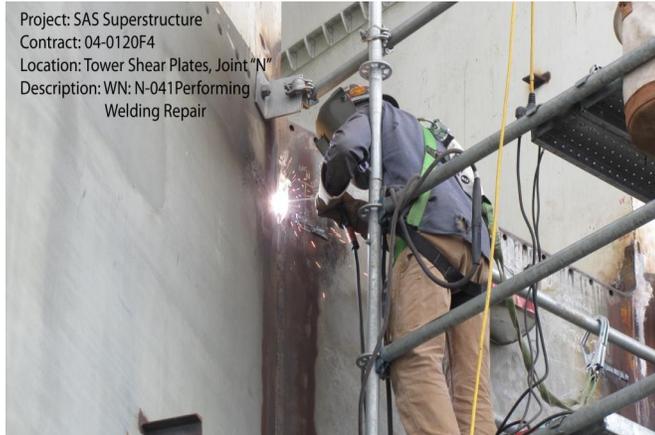
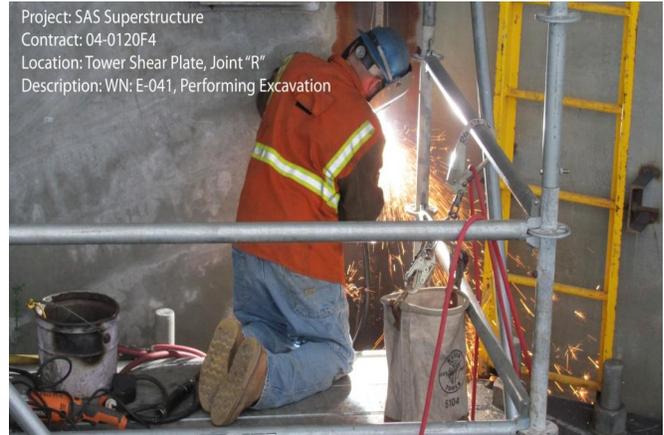
The digital photographs below illustrate some of the work observed during this scheduled work date.
