DEPARTMENT OF TRANSPORTATION

Quality Assurance and Source Inspection

Contract #: 04-0120F4Cty: SF/ALA Rte: 80 PM: 13.2/13.9File #: 1.28**WELDING INSPECTION REPORT****Resident Engineer:** Siegenthaler, Peter**Address:** 333 Burma Road**City:** Oakland, CA 94607**Report No:** WIR-026125**Date Inspected:** 19-Aug-2011**Project Name:** SAS Superstructure**OSM Arrival Time:** 700**Prime Contractor:** American Bridge/Fluor Enterprises, a JV**OSM Departure Time:** 1530**Contractor:** American Bridge/Fluor Enterprises, a JV**Location:** Job Site**CWI Name:** Steve Mc Connell**CWI Present:** Yes No**Inspected CWI report:** Yes No N/A**Rod Oven in Use:** Yes No N/A**Electrode to specification:** Yes No N/A**Weld Procedures Followed:** Yes No N/A**Qualified Welders:** Yes No N/A**Verified Joint Fit-up:** Yes No N/A**Approved Drawings:** Yes No N/A**Approved WPS:** Yes No N/A**Delayed / Cancelled:** Yes No N/A**Bridge No:** 34-0006**Component:** SAS Tower**Summary of Items Observed:**

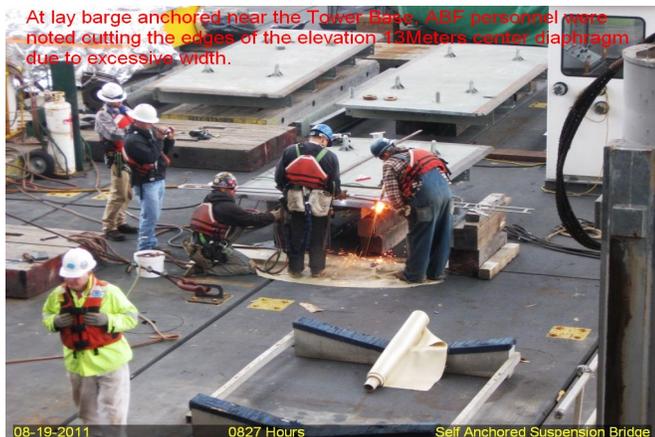
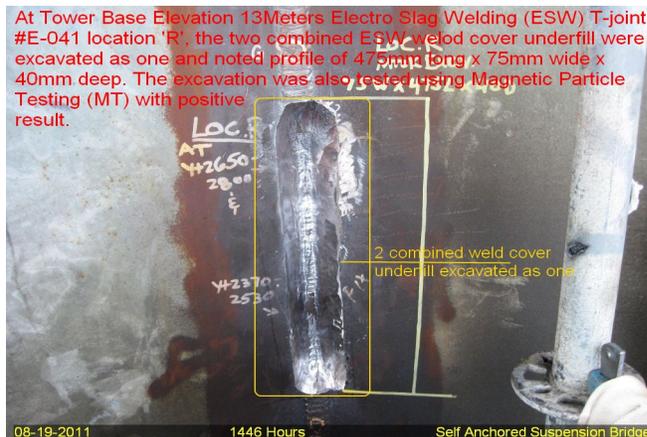
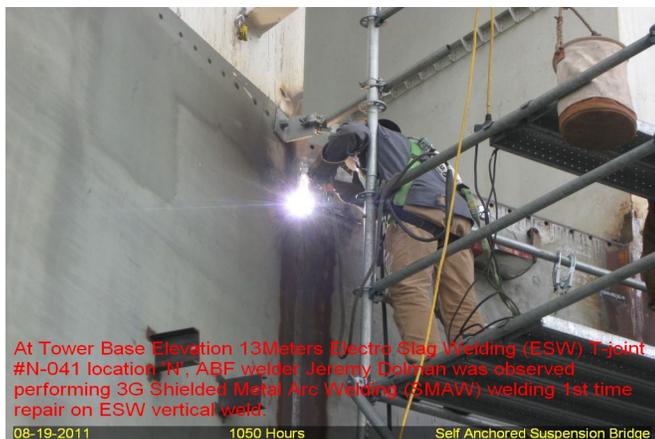
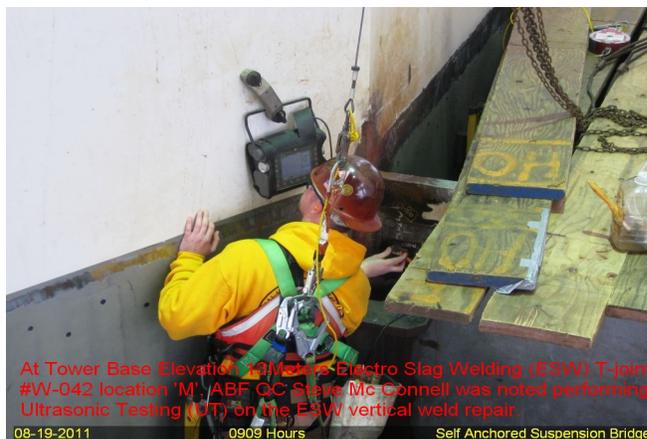
At Tower Base Elevation 13Meters, Electro Slag Welding (ESW) T-joint N-041 location 'N', QA randomly ABF welder Jeremy Dolman continuing to perform 3G SMAW first time welding repair (R1) on the Ultrasonic Testing (UT) detected defect on the vertical weld of the ESW per Repair Welding Request (RWR) #201108-013. The welder was observed welding in the 3G (vertical) position utilizing Shielded Metal Arc Welding (SMAW) with 1/8" diameter E7018H4R electrode implementing welding procedure ABF-WPS-D15-1000-Repairs. The boat shape repair located at Y=9450mm was excavated to dimensions of 170mm long x 75mm wide x 40mm deep. The excavation was previously tested using Magnetic Particle Testing (MT) by ABF QC John Pagliero and fellow QA Danny Reyes. The repair excavation and the adjacent base metal was preheated to more than 300°F using propylene gas torch prior welding. During the shift, ABF QC Steve Mc Connell was noted monitoring the welder. Measured welding parameter during welding was 120 amperes on a 1/8" diameter E7018H4R electrode. At the end of the shift, cover pass welding of the repair mentioned above was completed.

At Tower Base Elevation Electro Slag Welding (ESW) T-joint #E-041 location 'R', ABF welder Richard Garcia was noted continuing to excavate the weld cover underfill that was noted after the ESW. The welder was using carbon air arc gouging and die grinder to excavate the gouged groove of the excavation. At the end of the shift, the excavation was completed at Y=2330mm with boat shape profile of 475mm long x 75mm wide x 40mm deep. This excavation was a combination of two (2) underfill that were close to each other that the welder has excavated.

The excavation was tested by ABF QC Steve Mc Connell using Magnetic Particle Testing (MT) and verified by this QA with positive result.

At the lay down barge near the Tower Base, ABF welder Rory Hogan was noted cutting the edges of the elevation 13 Meters center diaphragm due to excessive length and width. The welder has cut the edges using oxygen-propylene gas torch with nozzle attached to a track with the same bevel profile. The face of the bevel was also noted ground smooth. Other diaphragms that were installed at the end of the shift were inner East, inner West and outer West.
