**DEPARTMENT OF TRANSPORTATION**

Contract #: 04-0120F4Cty: SF/ALA Rte: 80 PM: 13.2/13.9File #: 1.28**WELDING INSPECTION REPORT****Resident Engineer:** Siegenthaler, Peter**Address:** 333 Burma Road**City:** Oakland, CA 94607**Report No:** WIR-026153**Date Inspected:** 20-Aug-2011**Project Name:** SAS Superstructure**OSM Arrival Time:** 700**Prime Contractor:** American Bridge/Fluor Enterprises, a JV**OSM Departure Time:** 1530**Contractor:** American Bridge/Fluor Enterprises, a JV**Location:** Job Site**CWI Name:** See Below**CWI Present:** Yes No**Inspected CWI report:** Yes No N/A**Rod Oven in Use:** Yes No N/A**Electrode to specification:** Yes No N/A**Weld Procedures Followed:** Yes No N/A**Qualified Welders:** Yes No N/A**Verified Joint Fit-up:** Yes No N/A**Approved Drawings:** Yes No N/A**Approved WPS:** Yes No N/A**Delayed / Cancelled:** Yes No N/A**Bridge No:** 34-0006**Component:** SAS Tower & OBG**Summary of Items Observed:**

# WELDING INSPECTION REPORT

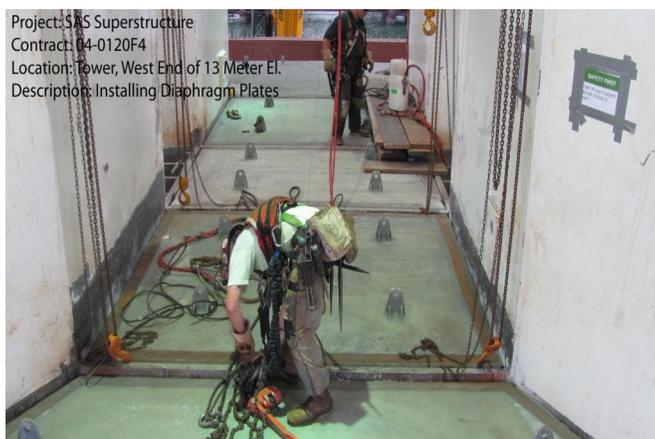
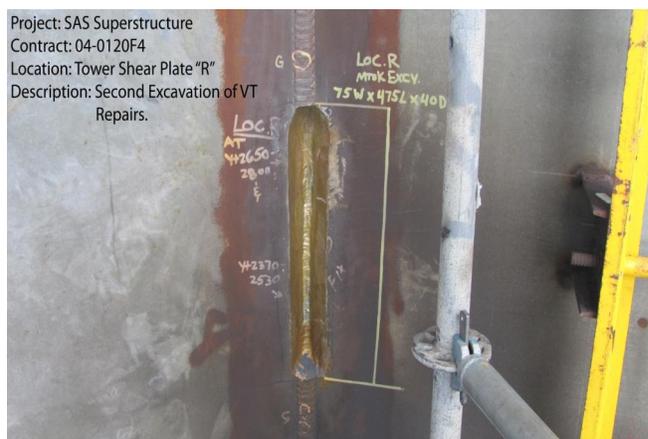
The digital photographs below illustrate some of the work observed during this scheduled work date.
