DEPARTMENT OF TRANSPORTATION

Contract #: 04-0120F4Cty: SF/ALA Rte: 80 PM: 13.2/13.9File #: 1.28**WELDING INSPECTION REPORT****Resident Engineer:** Siegenthaler, Peter**Address:** 333 Burma Road**City:** Oakland, CA 94607**Report No:** WIR-026154**Date Inspected:** 22-Aug-2011**Project Name:** SAS Superstructure**OSM Arrival Time:** 700**Prime Contractor:** American Bridge/Fluor Enterprises, a JV**OSM Departure Time:** 1530**Contractor:** American Bridge/Fluor Enterprises, a JV**Location:** Job Site**CWI Name:** See Below**CWI Present:** Yes No**Inspected CWI report:** Yes No N/A**Rod Oven in Use:** Yes No N/A**Electrode to specification:** Yes No N/A**Weld Procedures Followed:** Yes No N/A**Qualified Welders:** Yes No N/A**Verified Joint Fit-up:** Yes No N/A**Approved Drawings:** Yes No N/A**Approved WPS:** Yes No N/A**Delayed / Cancelled:** Yes No N/A**Bridge No:** 34-0006**Component:** SAS Tower & OBG**Summary of Items Observed:**

WELDING INSPECTION REPORT

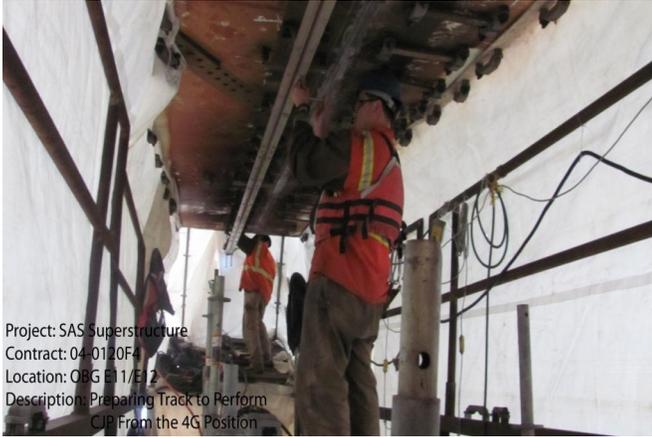
The QAI observed the continued CJP welding of the bottom plate field splice identified as 11E-12E-D utilizing the semi-automatic FCAW-G welding process as per the WPS ABF-WPS-D15-3042B-1 Rev. 0. The welding was performed by the welding operator James Zhen ID-6001 and the inspection was performed by the QC inspector William Sherwood utilizing the Welding Procedure Specification (WPS) as a reference during the monitoring of the welding and the verifying of the welding parameters. The welding parameters were measured by the QC inspector and were observed as follows; 245 amps, 24.3 volts and 183 mm/m. The welding was performed in the overhead (4G) position with the work placed in an approximately horizontal plane and the weld metal deposited from the underside. The welding was not completed during this shift and appeared to comply with the contract documents.

Project: SAS Superstructure
Contract: 04-0120F4
Location: OBG E11/E12
Description: Preparing Track to Perform
CIP From the 4G Position

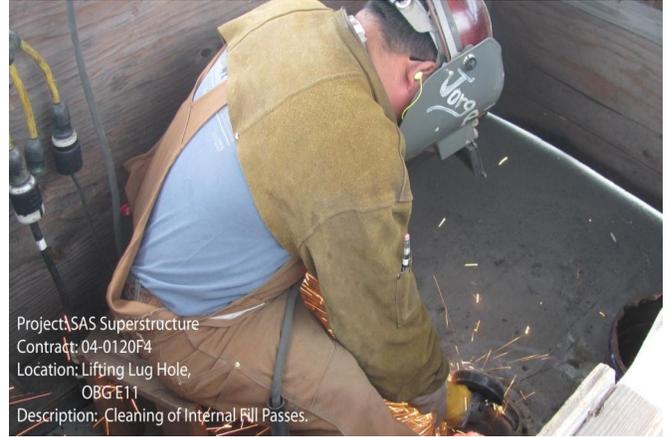
The QA inspector observed the CJP welding of the Lifting Lug Hole identified as WN: 11E-PP101-E4-W2 and W4. The welding was performed by the welder Jorge Lopez ID-6149 utilizing the SMAW as per the WPS identified as ABF-WPS-D15-1050A-CU Rev. 0 which was also used by the QC inspector as a reference to monitor the welding and verify the welding parameters. The QC inspection and the work associated with the weld inspection was performed by Fred Von Hoff. The welding was performed in the flat (1G) position with the work placed in an approximate horizontal plane and the weld metal deposited from the upper side. The welding was not completed during this shift.

Project: SAS Superstructure
Contract: 04-0120F4
Location: Lifting Lug Hole,
OBGE11
Description: Cleaning of Internal Fill Passes.
