DEPARTMENT OF TRANSPORTATION

Quality Assurance and Source Inspection

Contract #: 04-0120F4Cty: SF/ALA Rte: 80 PM: 13.2/13.9File #: 1.28**WELDING INSPECTION REPORT****Resident Engineer:** Siegenthaler, Peter**Address:** 333 Burma Road**City:** Oakland, CA 94607**Report No:** WIR-026155**Date Inspected:** 23-Aug-2011**Project Name:** SAS Superstructure**OSM Arrival Time:** 700**Prime Contractor:** American Bridge/Fluor Enterprises, a JV**OSM Departure Time:** 1530**Contractor:** American Bridge/Fluor Enterprises, a JV**Location:** Job Site**CWI Name:** See Below**CWI Present:** Yes No**Inspected CWI report:** Yes No N/A**Rod Oven in Use:** Yes No N/A**Electrode to specification:** Yes No N/A**Weld Procedures Followed:** Yes No N/A**Qualified Welders:** Yes No N/A**Verified Joint Fit-up:** Yes No N/A**Approved Drawings:** Yes No N/A**Approved WPS:** Yes No N/A**Delayed / Cancelled:** Yes No N/A**Bridge No:** 34-0006**Component:** SAS Tower & OBG**Summary of Items Observed:**

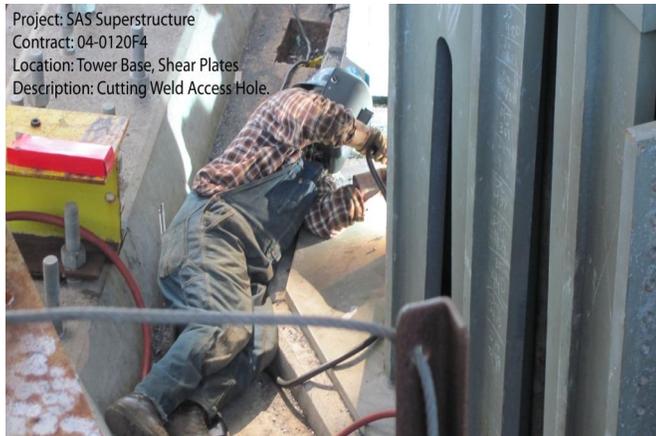
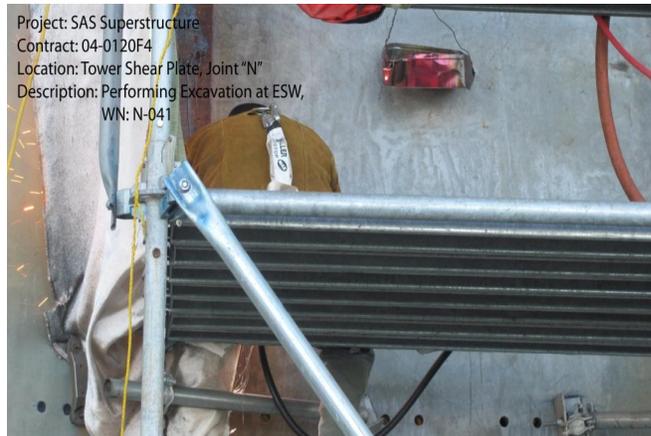
The digital photographs on page 3 of this report illustrate some of the work observed during this scheduled work date.
