Contract #: 04-0120F4Cty: SF/ALA Rte: 80 PM: 13.2/13.9File #: 1.28**WELDING INSPECTION REPORT****Resident Engineer:** Siegenthaler, Peter**Address:** 333 Burma Road**City:** Oakland, CA 94607**Report No:** WIR-026157**Date Inspected:** 20-Aug-2011**Project Name:** SAS Superstructure**OSM Arrival Time:** 700**Prime Contractor:** American Bridge/Fluor Enterprises, a JV**OSM Departure Time:** 1530**Contractor:** American Bridge/Fluor Enterprises, a JV**Location:** Job Site

CWI Name:	Steve Mc Connell and Fred Von Hoff			OSM Present:	Yes	No	
Inspected CWI report:	Yes	No	N/A	Rod Oven in Use:	Yes	No	N/A
Electrode to specification:	Yes	No	N/A	Weld Procedures Followed:	Yes	No	N/A
Qualified Welders:	Yes	No	N/A	Verified Joint Fit-up:	Yes	No	N/A
Approved Drawings:	Yes	No	N/A	Approved WPS:	Yes	No	N/A
				Delayed / Cancelled:	Yes	No	N/A
Bridge No:	34-0006			Component:	SAS Tower

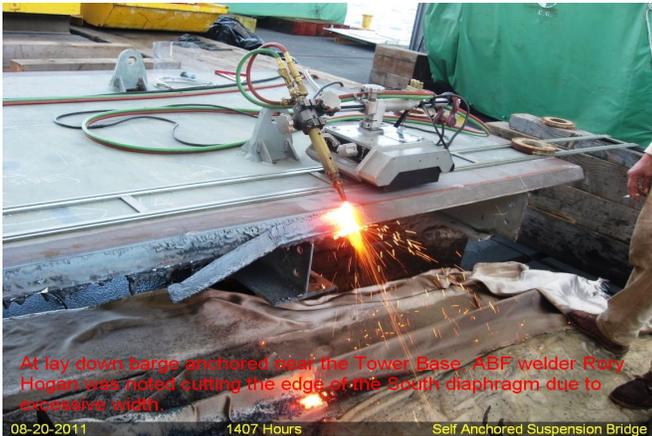
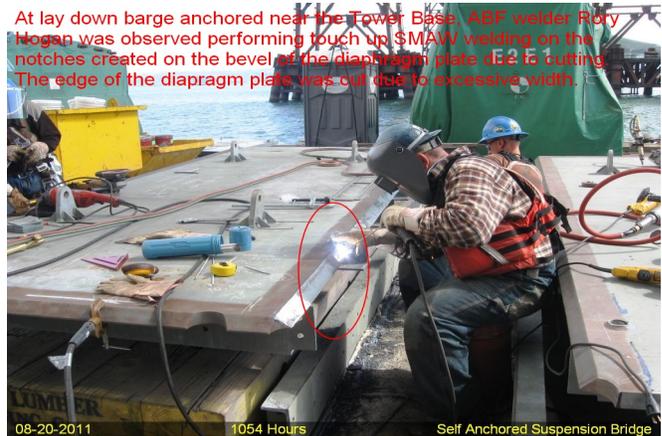
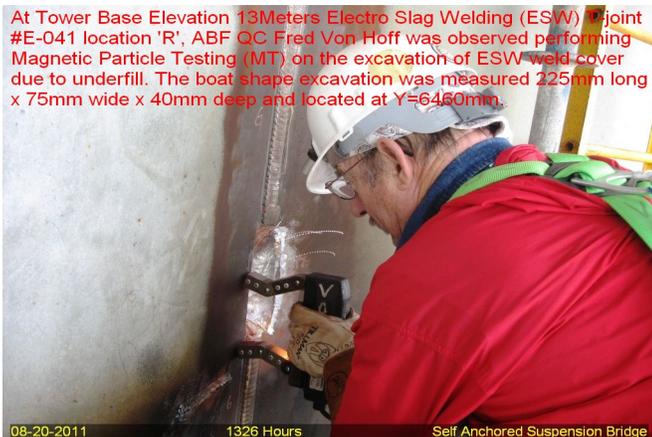
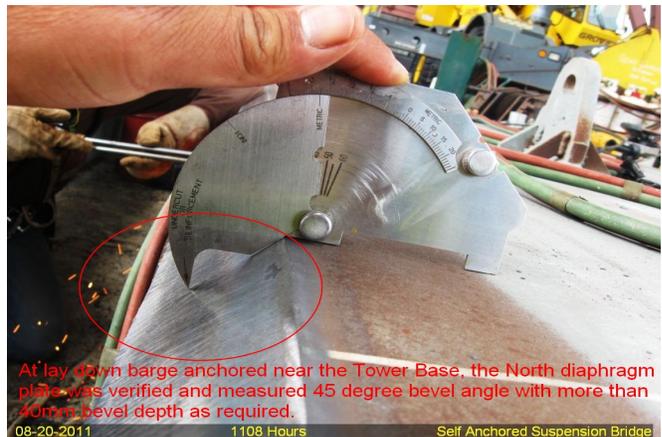
At Tower Base Elevation Electro Slag Welding (ESW) T-joint #E-041 location 'R', ABF welder Richard Garcia was noted continuing to excavate the weld cover underfill that was noted after the ESW. The welder was using carbon air arc gouging to excavate the cover underfill and die grinder to smooth ground the gouged groove of the excavation. At the end of the shift, the excavation was completed at Y=6460mm with boat shape profile of 225mm long x 75mm wide x 40mm deep. The excavation was tested by ABF QC Fred Von Hoff using Magnetic Particle Testing (MT) and verified by this QA with positive result.

At the lay down barge anchored near the Tower Base, ABF welder Rory Hogan was noted cutting the edges (2-sides) of the elevation 13 Meters north diaphragm due to excessive length and width. The welder has cut the edges using oxygen-propylene gas torch with nozzle attached to a track. The face of the bevel was also noted ground smooth. Minor touch up SMAW welding was performed on the bevel face due to notches that occurred during cutting. The welder was noted using 1/8" diameter E7018H4R electrode. The plate was also preheated to 150°F prior welding. ABF QC Fred Von Hoff was noted monitoring the welder's parameter during welding. After the work completion of the north diaphragm plate, this QA verified the bevel depth of more than 39mm and bevel angle of 45 degree as required. This diaphragm was put in place during the shift.

The elevation 13Meter south diaphragm was also needed to be cut on 2-sides of the plate due to excessive length

and width. ABF welder Rory Hogan was noted cutting the edge of the plate using oxygen-propylene gas torch with nozzle attached to a track. One side of the diaphragm plate was noted cut and being ground smooth at the end of the shift. According to the welder, the other side of the diaphragm plate will be cut and ground smooth on Monday.

At various ESW weld locations, ABF QC Steve Mc Connell and William Sherwood were observed performing Magnetic Particle Inspection (MT). The vertical ESW weld joints at locations 'N', 'W', 'R' and 'S' were MT'd from the inside with noted grinding remarks marked on the plates to be later performed by ABF personnel.
