**DEPARTMENT OF TRANSPORTATION**

Contract #: 04-0120F4Cty: SF/ALA Rte: 80 PM: 13.2/13.9File #: 1.28**WELDING INSPECTION REPORT****Resident Engineer:** Siegenthaler, Peter**Address:** 333 Burma Road**City:** Oakland, CA 94607**Report No:** WIR-026158**Date Inspected:** 22-Aug-2011**Project Name:** SAS Superstructure**OSM Arrival Time:** 700**Prime Contractor:** American Bridge/Fluor Enterprises, a JV**OSM Departure Time:** 1730**Contractor:** American Bridge/Fluor Enterprises, a JV**Location:** Job Site**CWI Name:** John Pagliero**CWI Present:** Yes No**Inspected CWI report:** Yes No N/A**Rod Oven in Use:** Yes No N/A**Electrode to specification:** Yes No N/A**Weld Procedures Followed:** Yes No N/A**Qualified Welders:** Yes No N/A**Verified Joint Fit-up:** Yes No N/A**Approved Drawings:** Yes No N/A**Approved WPS:** Yes No N/A**Delayed / Cancelled:** Yes No N/A**Bridge No:** 34-0006**Component:** SAS Tower**Summary of Items Observed:**

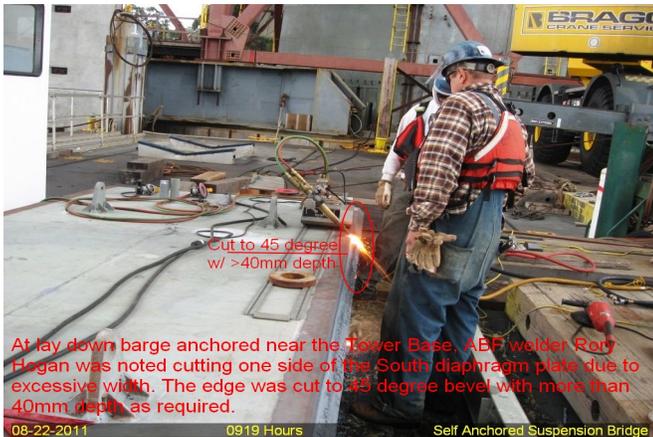
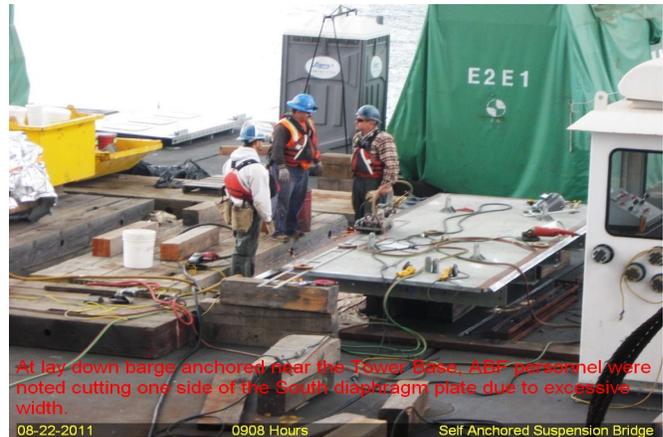
At the lay down barge anchored near the Tower Base, ABF welder Rory Hogan was noted cutting one side of the elevation 13 Meters South diaphragm plate due to excessive width. The welder has cut the edge of the plate using oxygen-propylene gas torch with nozzle attached to a track. Minor touch up SMAW welding was performed on the bevel face due to notches that occurred during cutting. The welder was noted using 1/8" diameter E7018H4R electrode. The plate was also preheated to 150°F prior welding. ABF QC John Pagliero was noted monitoring the welder's parameter during welding. The face of the bevel was also noted ground smooth. After the work completion of the north diaphragm plate, this QA verified the bevel depth of more than 39mm and bevel angle of 45 degree as required and deemed in compliance with the contract requirements. This diaphragm was put in place at the Tower during the shift.

At ESW location 'R' outside, ABF welder Richard Garcia was noted setting up the Miller Proheat 35 Induction Heating System to be used repairing various locations of the ESW vertical weld joint. The welder was setting up at repair excavation Y=6460mm and put the heater blankets inside. The welder was also noted placing the thermocouples to the plates in preparation for the repair welding. At the end of the shift, all preparations for the repair welding were completed.

At ESW location 'W' outside, ABF welder Jeremy Dolman was noted removing the remnants of the cut strong

back along the vertical weld joints that were used during the ESW. The welder was noted using carbon air arc gouging to remove the plates remnant and its weld. The work is still in progress.
