DEPARTMENT OF TRANSPORTATION

Contract #: 04-0120F4Cty: SF/ALA Rte: 80 PM: 13.2/13.9File #: 1.28**WELDING INSPECTION REPORT****Resident Engineer:** Siegenthaler, Peter**Address:** 333 Burma Road**City:** Oakland, CA 94607**Report No:** WIR-026160**Date Inspected:** 23-Aug-2011**Project Name:** SAS Superstructure**OSM Arrival Time:** 700**Prime Contractor:** American Bridge/Fluor Enterprises, a JV**OSM Departure Time:** 1730**Contractor:** American Bridge/Fluor Enterprises, a JV**Location:** Job Site**CWI Name:** John Pagliero**CWI Present:** Yes No**Inspected CWI report:** Yes No N/A**Rod Oven in Use:** Yes No N/A**Electrode to specification:** Yes No N/A**Weld Procedures Followed:** Yes No N/A**Qualified Welders:** Yes No N/A**Verified Joint Fit-up:** Yes No N/A**Approved Drawings:** Yes No N/A**Approved WPS:** Yes No N/A**Delayed / Cancelled:** Yes No N/A**Bridge No:** 34-0006**Component:** SAS Tower**Summary of Items Observed:**

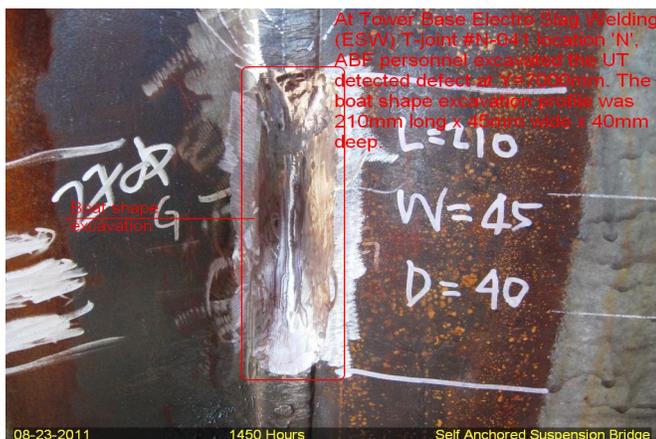
The welder has moved to ESW T-joint #N-041 location and performed excavation on the UT detected defect of the ESW vertical weld. The welder was noted using carbon air arc gouging followed by die/disc grinder to make the excavation smooth. After the excavation was completed, the welder had asked ABF QC John Pagliero for VT/MT. Magnetic Particle Testing (MT) was performed by QC John Pagliero and verified by this QA with positive result. The boat shape repair excavation was located at Y=7000mm with profile dimensions of 210mm long x 45mm wide x 40mm deep. ABF QC John Pagliero has informed this QA that ABF will initiate the Repair Welding Request (RWR) and perform the repair once it gets the approval.
