**DEPARTMENT OF TRANSPORTATION**

Quality Assurance and Source Inspection

Contract #: 04-0120F4Cty: SF/ALA Rte: 80 PM: 13.2/13.9File #: 1.28**WELDING INSPECTION REPORT****Resident Engineer:** Siegenthaler, Peter**Address:** 333 Burma Road**City:** Oakland, CA 94607**Report No:** WIR-026161**Date Inspected:** 24-Aug-2011**Project Name:** SAS Superstructure**OSM Arrival Time:** 700**Prime Contractor:** American Bridge/Fluor Enterprises, a JV**OSM Departure Time:** 1530**Contractor:** American Bridge/Fluor Enterprises, a JV**Location:** Job Site**CWI Name:** John Pagliero**CWI Present:** Yes No**Inspected CWI report:** Yes No N/A**Rod Oven in Use:** Yes No N/A**Electrode to specification:** Yes No N/A**Weld Procedures Followed:** Yes No N/A**Qualified Welders:** Yes No N/A**Verified Joint Fit-up:** Yes No N/A**Approved Drawings:** Yes No N/A**Approved WPS:** Yes No N/A**Delayed / Cancelled:** Yes No N/A**Bridge No:** 34-0006**Component:** SAS Tower**Summary of Items Observed:**

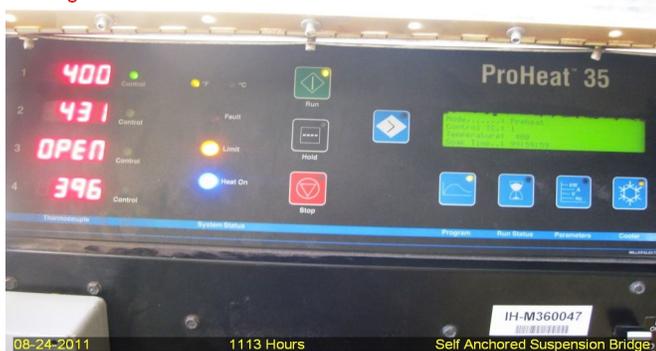
At Tower Base Electro Slag Welding (ESW) T-joint #E-041 location 'R', ABF personnel were noted using the Miller Proheat 35 Induction Heating System to preheat and maintain the required temperature prior repair welding.

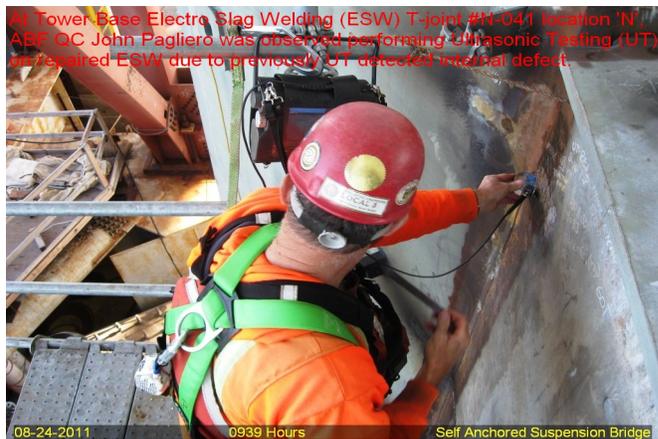
At ESW T-joint #N-041 location 'N', ABF QC John Pagliero was observed performing Magnetic Particle Testing (MT) and Ultrasonic Testing (UT) on the first time repair at Y=9540mm of the ESW vertical weld. The MT result was satisfactory and was also verified by this QA. The UT was not quite done due to presence of reflector/geometry at the opposite side of the repair that QC wants to be ground. The UT result will be kept pending until the reflector from the opposite side is verified and cleared.

At Tower Base Electro Slag Welding (ESW) T-joint #N-041 location 'N', ABF QC John Pagliero was observed performing Ultrasonic Testing (UT) on repaired ESW due to previously UT detected internal defect.

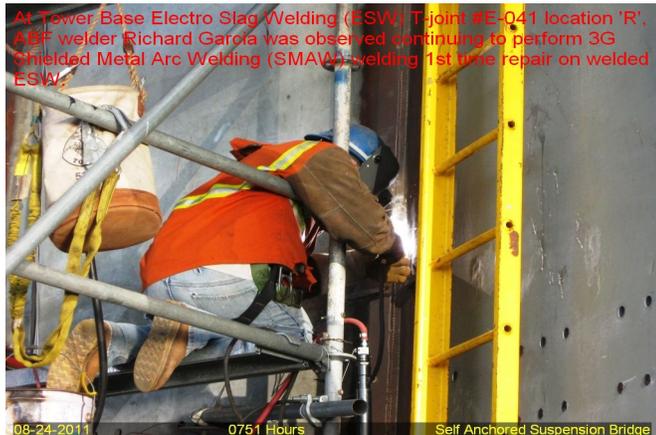
At Tower Base Elevation Electro Slag Welding (ESW) T-joint E-041 location 'R', QA randomly ABF welder Richard Garcia continuing to perform 3G SMAW first time welding repair (R1) on the visually (VT) detected defect on the surface of the vertical weld of the ESW. The welder was observed welding in the 3G (vertical) position utilizing Shielded Metal Arc Welding (SMAW) with 1/8" diameter E7018H4R electrode implementing welding procedure ABF-WPS-D15-1000-Repair Rev. 2. The boat shape repair located at Y=6460mm was excavated to dimensions of 225mm long x 75mm wide x 40mm deep. The excavation was previously tested using Magnetic Particle Testing (MT) by ABF QC Fred Von Hoff and this QA with positive result. The repair excavation and the adjacent base metal was preheated and maintained to more than 400°F using Miller Proheat Induction Heating System with the heater blankets placed at the other side of the repair. During the shift, ABF QC John Pagliero was noted monitoring the welder. Measured welding parameter during welding was 135 amperes on a 1/8" diameter E7018H4R electrode. Before the end of the shift, fill pass repair welding was still continuing and the observation of the job was turned over to Lead QA Danny Reyes for the remainder of the shift.

At Tower Base Electro Slag Welding (ESW) T-joint #E-041 location 'R', ABF welder Richard Garcia was observed continuing to perform 3G Shielded Metal Arc Welding (SMAW) welding 1st time repair on welded ESW.
